*Southwest Metro Station Upgrade Works Package 4:
Marrickville, Canterbury & Lakemba Stations*

HSEJV Construction Monitoring Report: March – August 2021

Document Number: SMCSWSW4-HSE-WEC-EM-REP-003632

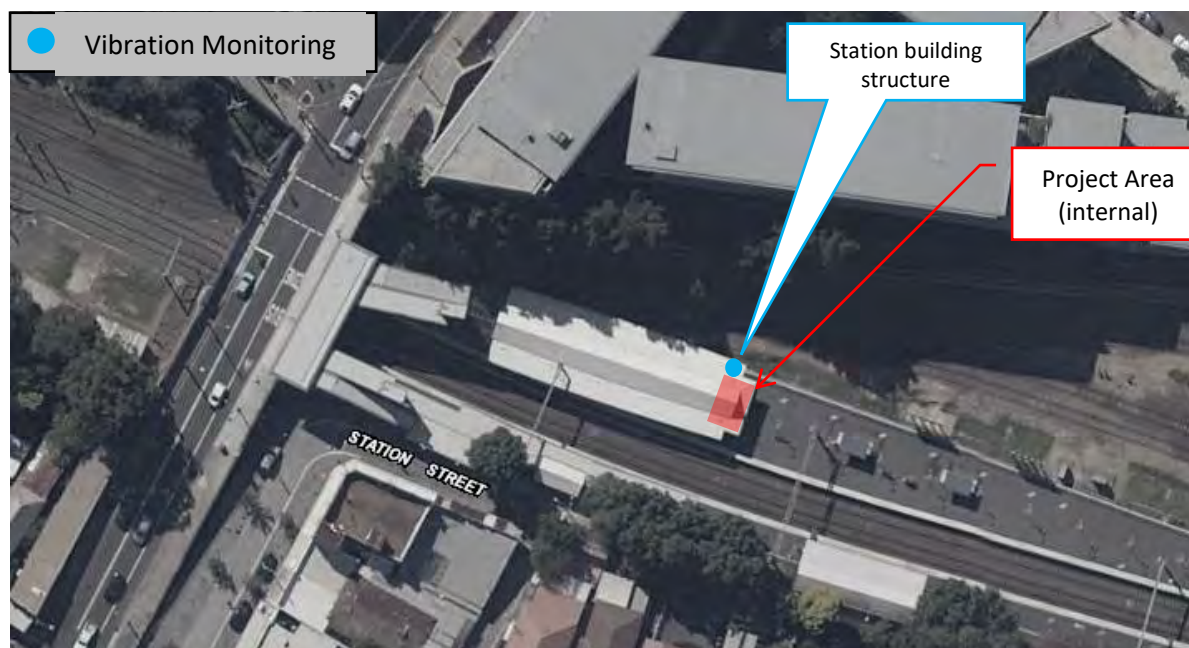
Figure 1 Attended Vibration Monitoring Location

Task	Period	Receiver Type	Location	Monitoring Type
Vibration Monitoring	Daytime	Infrastructure (Heritage)	Station Building (Platform 1)	Operator-Attended

A preliminary measurement and assessments of the internal demolition works within the Station Building (Heritage Building) was carried out on Wednesday 19 May 2021. During the survey, the following works were observed:

The vibration levels were measured during the operation of jackhammer and found that the measured levels were between 4.0 mm/s (13 Hz) and 10.5 mm/s (13 Hz). This is in exceedance of the nominated Building Damage Vibration Goals (Section 5.7, CNVMP) for Heritage building (Structurally Sound) of 7.5 mm/s.

The measured vibration levels during general activity were noted to be semi-continuous whereby the activity occurred most of the time during the observation and can be considered as typical.

The measured high vibration level events were observed to be isolated and does not a regular occurrence. The vibration levels are likely due to direct impact immediately on the wall behind the accelerometer.

Further review of the condition reports (see list below) carried out by the project team resulted in adjustment to the vibration screening level from 7.5mm/s to 25 mm/s.

Additionally, VMS recommends that a post construction condition survey is carried out to capture condition of the structure.
