*Southwest Metro Station Upgrade Works Package 4:
Marrickville, Canterbury & Lakemba Stations*

HSEJV Construction Monitoring Report: Sept 2021 – Feb 2022

Document Number: SMCSWSW4-HSE-WEC-EM-REP-006290

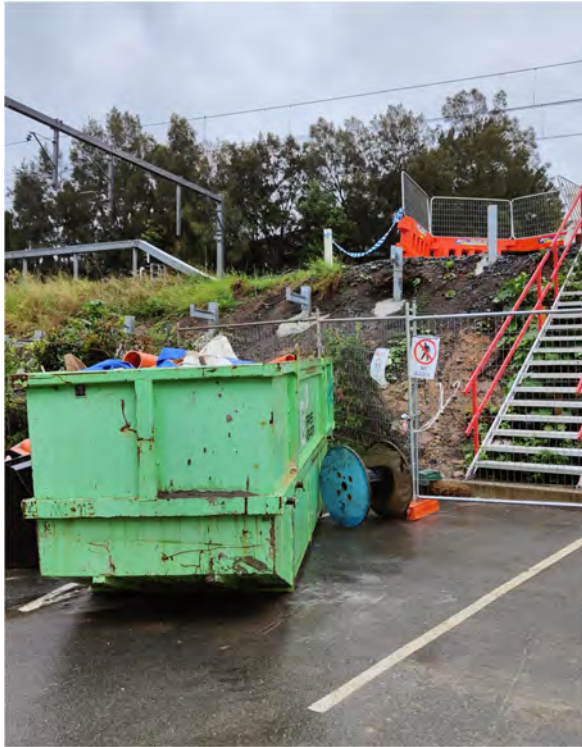
1. The disturbed rail embarkment must be stabilised (e.g. sprayed with polymer or covered with geofabric).

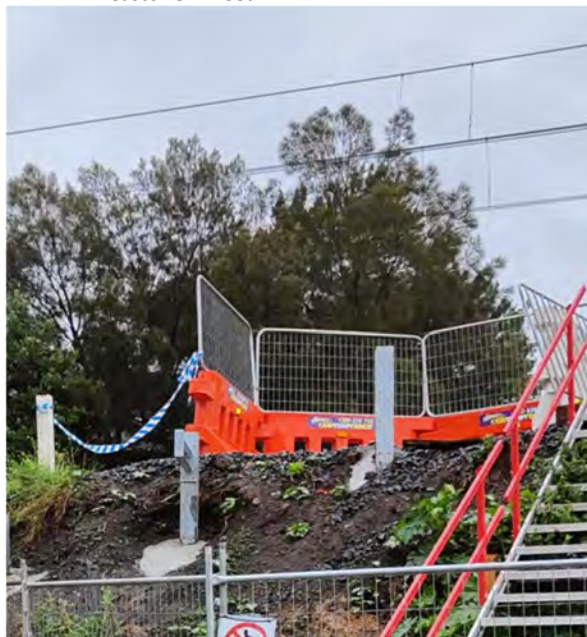
Castor Oil Weed

2. The MSB area (railway embankment) is overgrown with weeds. Weeds shall be sprayed in the MSB area.

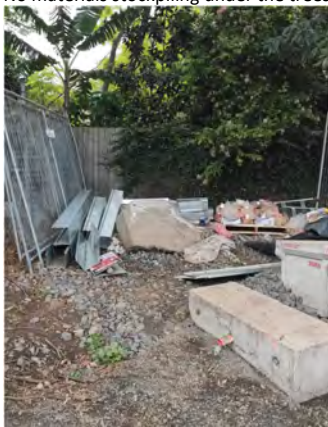
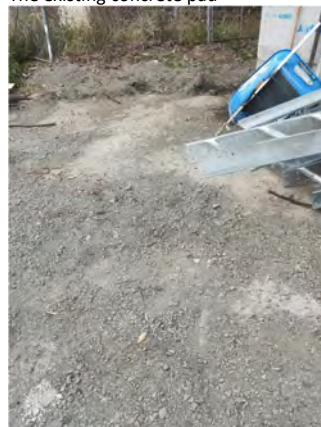
1. Photos Construction materials were stacked too close to a tree outside of the project boundary. Materials must be moved from under the dripline and placed onto the existing concrete pad at Wooley Ln.

No materials stockpiling under the trees

The existing concrete pad

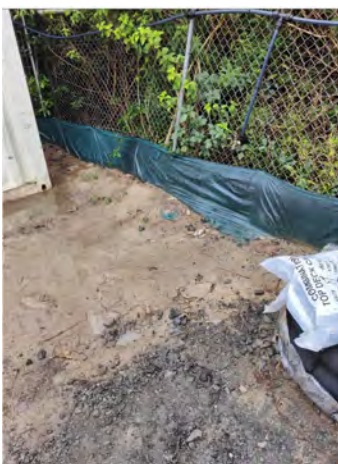
2. It was noted that sediment fence was installed incorrectly (gap between fence and ground). Sed fence needs to be dug in. Minor repair of the sed fence along the drainage channel in the MSB area is required.

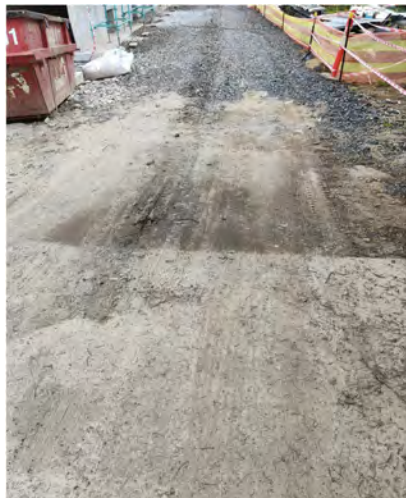
3. It is recommended to stabilize entry point at the MSB area (ARTC Access point).

25b 25.01.2022	It is recommended to stabilize entry point at the MSB area (ARTC Access point) by adding aggregate materials.	JBlanch/ MBroughton

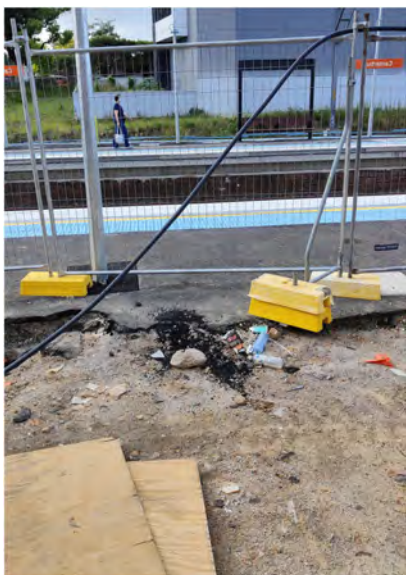
1. Waste bins provided must be used and subcontractors made aware of where to throw household waste

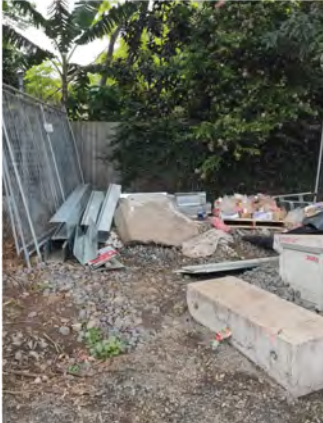
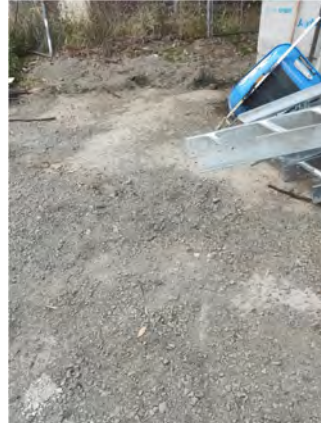
1. Photos Construction materials were stacked too close to a tree outside of the project boundary. Materials must be moved from under the dripline and placed onto the existing concrete pad at Wooley Ln.

No materials stockpiling under the trees

The existing concrete pad

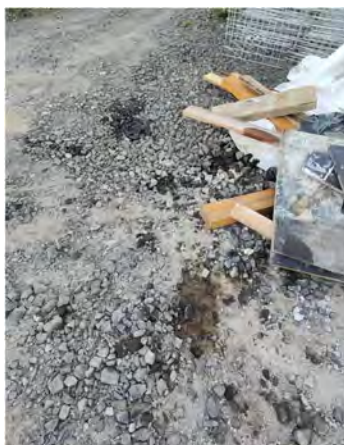
2. During the inspection, a small spill was discovered in the MSB area. Remove contaminated aggregate materials and dispose them appropriately. Provide details of the spill incident.

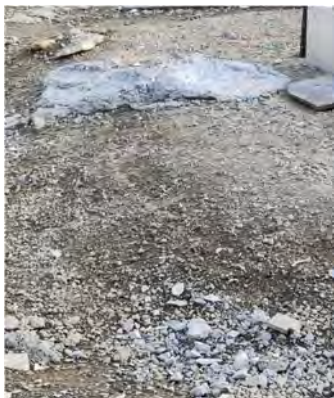
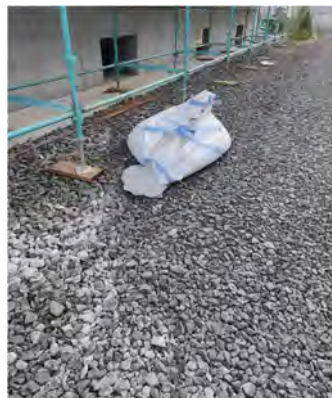
3. Clean up the MSB area from spilled concrete.

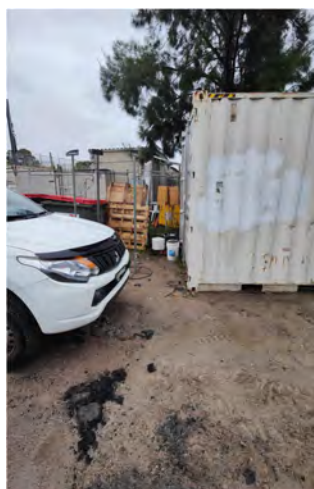
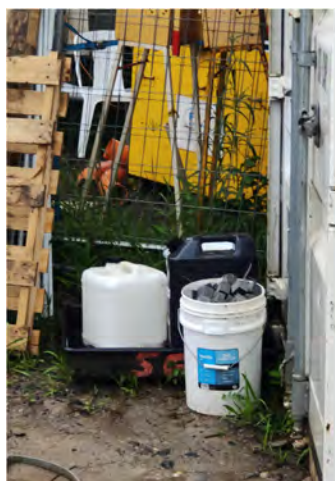
4. The chemical storage bunds must be emptied and collected rainwater shall be disposed of as liquid waste due to potential hydrocarbons contamination.
The chemical storage bunds capacity should be 110% of the volume of the largest container or 25% of the total volume.
Please place the portable bund with chemicals undercover during the rainy weather.

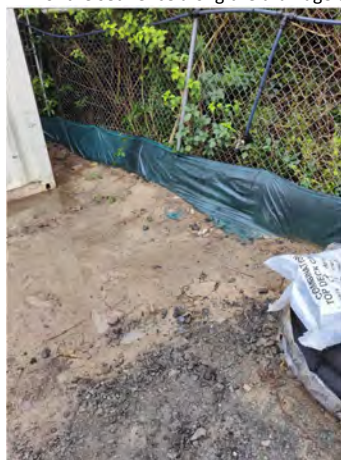
5. It was noted that sediment fence was installed incorrectly (gap between fence and ground). Sed fence needs to be dug in. Minor repair of the sed fence along the drainage channel in the MSB area is required.

25b 19.01.2022	It was noted that sediment fence was installed properly (gap between fence and ground). Minor repair of the sediment fence along the drainage channel in the MSB area is required.	JBlanch/ MBroughton
