Southwest Metro Station Upgrade Works Package 4: Marrickville, Canterbury & Lakemba Stations

HSEJV Construction Monitoring Report: March – August 2022

Document Number: SMCSWSW4-HSE-WEC-EM-REP-007659 Revision Date: 31/10/2022 Revision: B

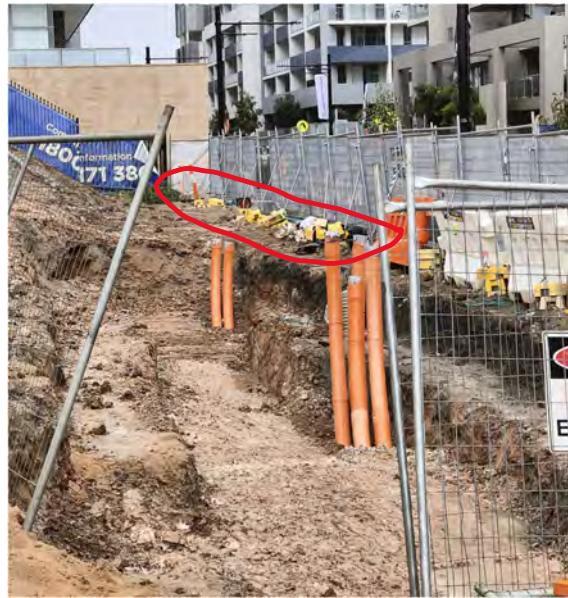
1. It is recommended to restore the sediment controls at the main compound along Charles Street.

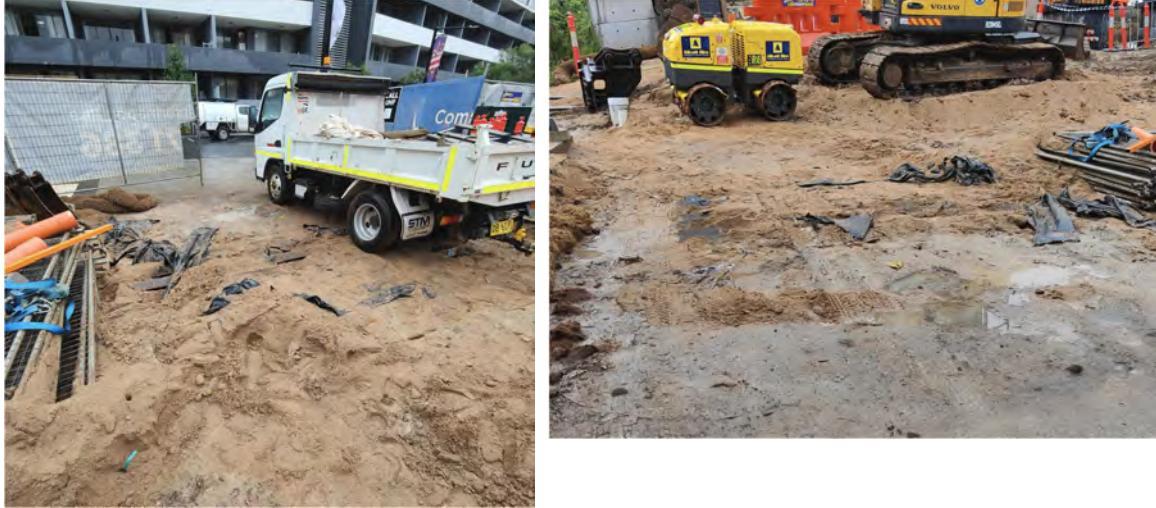
2. It is recommended to clean the rumble grid and stabilise the main site access point.

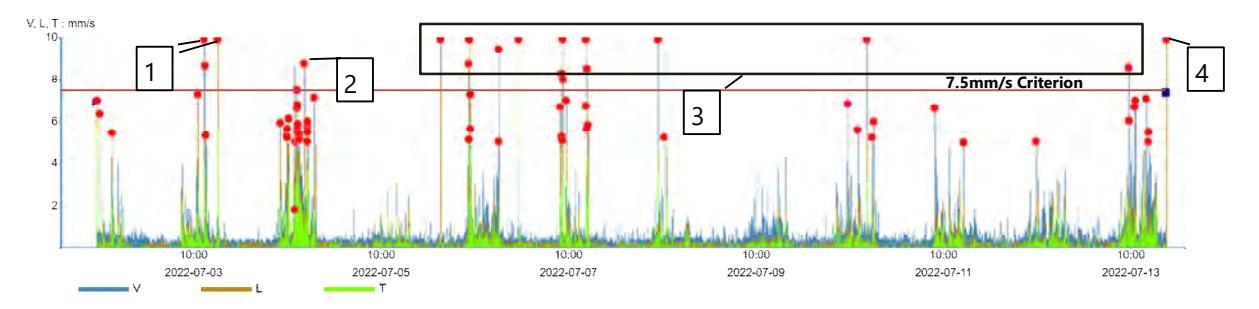
Figure 4-1: Unattended Canterbury Station vibration monitoring results (refer to Appendix A.2)

The results of the unattended vibration measurements for the affected structure are presented in Figure 4-1 below.

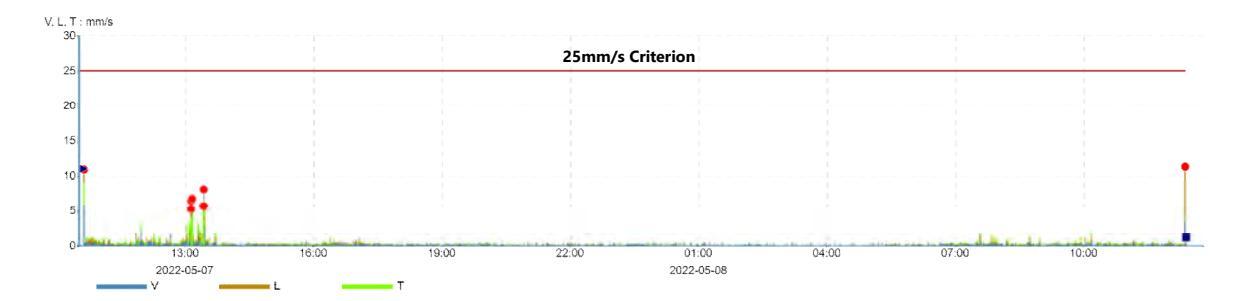
It can be seen in Figure 4-1 that the vibration levels produced from the nearby construction works are below 25 mm/s.

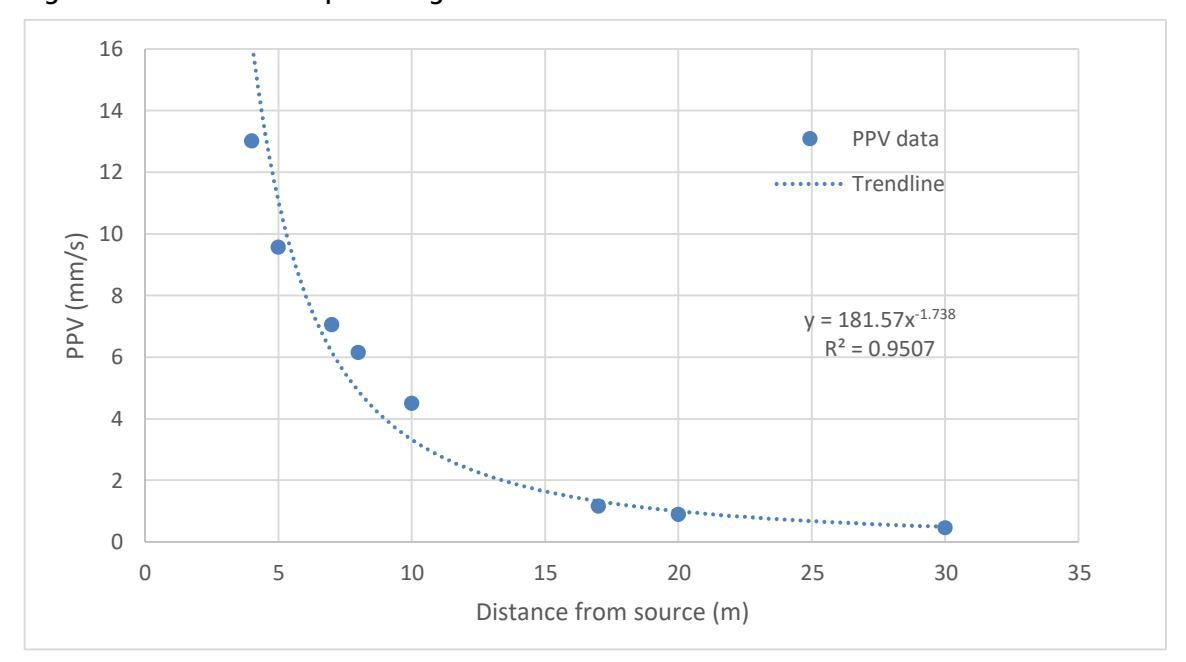
Figure 3-1: Measured PPV plotted against distance from vibration source

Measurement ID	Plant	Distance from source	Baseline 95 th percentile PPV	95th percentile PPV (mm/s)	Maximum PPV (mm/s)	Comments
М3	40T vibratory piling rig	7m	0.09	6.45	7.06	At 7 metres away, the 40T vibratory piling rig produced vibration levels that are above the screening level for human annoyance for day and night hours.
M4	40T vibratory piling rig	8m	0.09	5.24	6.15	At 8 metres away, the 40T vibratory piling rig produced vibration levels that are above the screening level for human annoyance for day and night hours.
M5	40T vibratory piling rig	10m	0.09	3.99	4.50	At 10 metres away, the 40T vibratory piling rig produced vibration levels that are above the screening level for human annoyance for day and night hours.
M6	40T vibratory piling rig	17m	0.09	0.85	1.17	At 17 metres away, the 40T vibratory piling rig produced vibration levels that are above the screening level for human annoyance for day and night hours.

M7	40T vibratory piling rig	20m	0.09	0.75	0.90	At 20 metres away, the 40T vibratory piling rig produced vibration levels that are above the screening level for human annoyance for day and night hours.
M8	40T vibratory piling rig	30m	0.09	0.41	0.46	At 30 metres away, the 40T vibratory piling rig produced vibration levels that are below the screening level for human annoyance for day hours and above the screening level for human annoyance for night hours.

The site-specific human annoyance minimum working distances are extrapolated from the fitted trendline in Figure 3-1. The results of the extrapolated minimum working distances are shown in Table 3-2 below.
