Lakemba Station Catchment Construction Works

Archaeological method statement for WE38

Prepared for HSEJV
March 2021

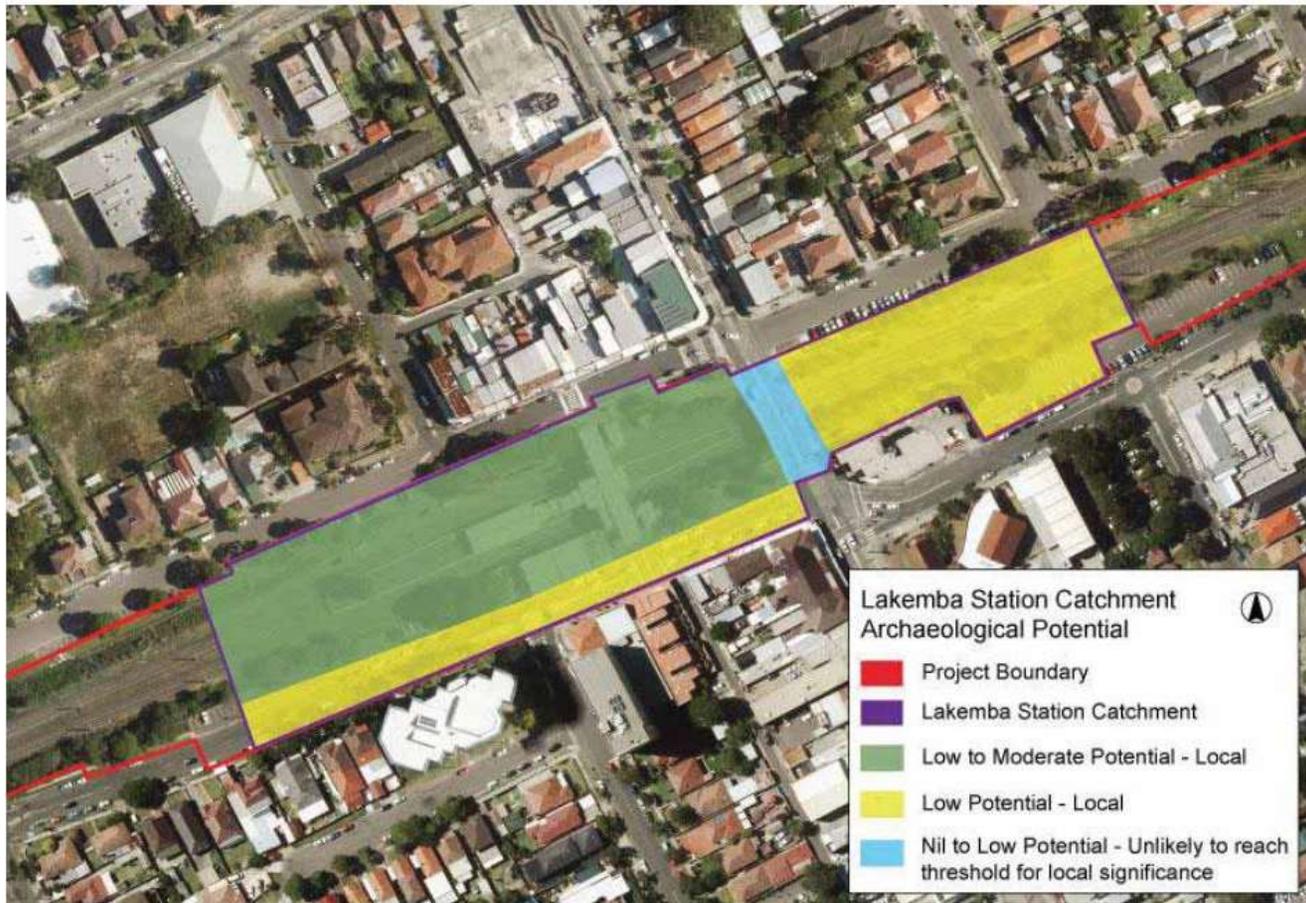
Plate 1.1 Archaeological potential of the project area. Work associated with WE38 will be occurring in the green 'low to moderate' zone. Source: Artefact Heritage 2018, Figure 6-18. p.121.

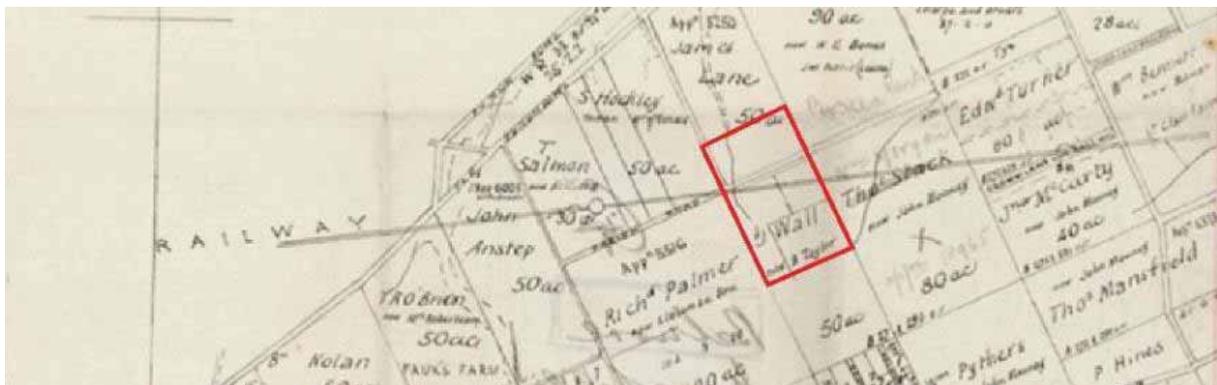
Figure 6-2: Undated plan showing approximate alignment of the proposed railway. Wall and Taylor's grant has been outlined in red. Source: SLNSW call no. Z/SP/B12.

The suburb of Lakemba was originally located within John Wall's 1831 grant of 50 acres, called "Ashford". During this time the area was relatively undeveloped with much of the land being forest. In August 1881 Ben Taylor leased "Ashford", before purchasing the property in 1890 (Figure 6-2). Figure 6-3 shows Taylors house on this grant prior to the construction of the railway line, consisting of a house and stable building. Additional outbuildings may have occupied land around the main property, and therefore within the study area.

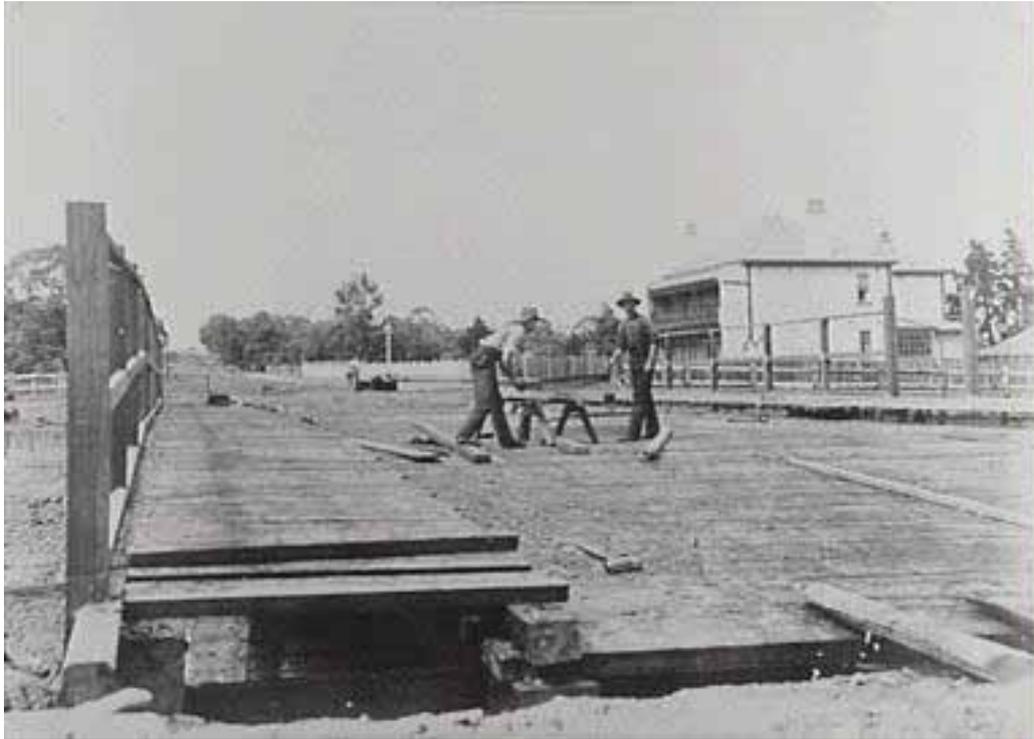
Figure 6-6: Construction of timber bridge over railway line at Haldon Street, with Lakemba house in the background right c. 1931. Source: Pictorial Canterbury, City of Canterbury Council.

In 1883, Taylor married his second wife Lucy Annie Johnston, the granddaughter of missionaries based on Lakeba Island in Fiji (pronounced Lakemba).⁵⁷ Soon after their marriage, Taylor named his house "Lakemba," and by the 1920s it was a substantial two-storey residence to the south of the study area (Figure 6-4, Figure 6-5, Figure 6-6).

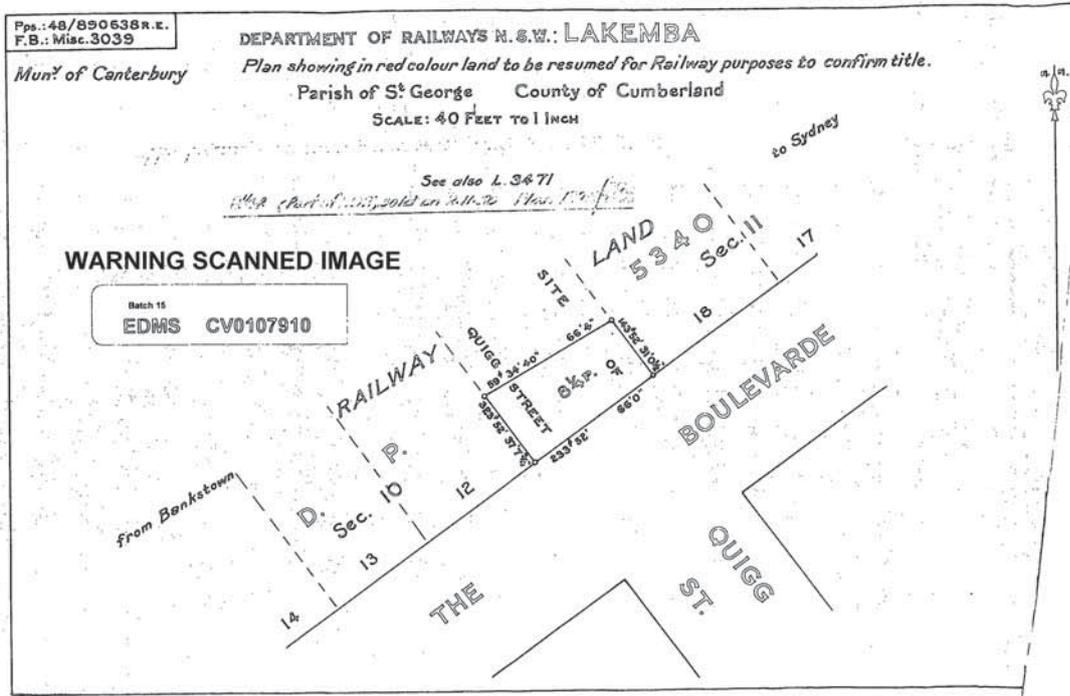
Figure 6-9: Plan of the land to be resumed for Lakemba Railway Station. Source: Sydney Trains Plan Room.

Prior to the arrival of the railway, the surrounding area consisted predominantly of bushland dotted with the occasional small homestead (Figure 6-9). Early industry included a tannery in Wangee Road, charcoal burning and brickmaking.⁵⁸ Commercial nurseries, such as Horton's, and small poultry farms, were also located throughout the area. A piggery was originally located on Haldon Street (Figure 6-10).⁵⁹

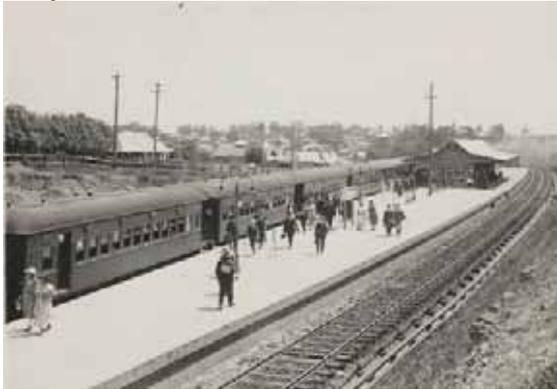
Figure 6-12: Lakemba Station c.1920. Source: National Library of Australia nla.pic-vn4543845-v.

On 24 December 1919, a new brick platform building with cantilever awnings replaced the earlier timber structure (Figure 6-12) and a signal box was opened at the Bankstown end of the station.

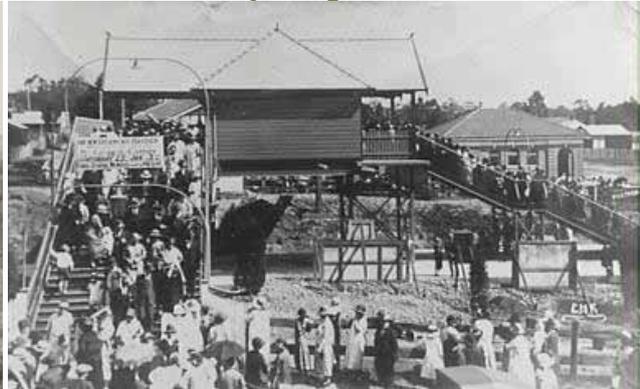
Figure 6-13: Opening of the overhead bridge. Source: City of Canterbury Library Collection via Pictorial Canterbury, Image No. 30416.

The station was modified for electrification in 1926 and a haunched beam footbridge with overhead timber-framed booking office erected (Figure 6-13).⁶⁰ The booking office was demolished after fire damage and replaced by a modern metal and glass structure on the footbridge in 2001 consisting of a new booking office, a central concourse and a concessionaire.

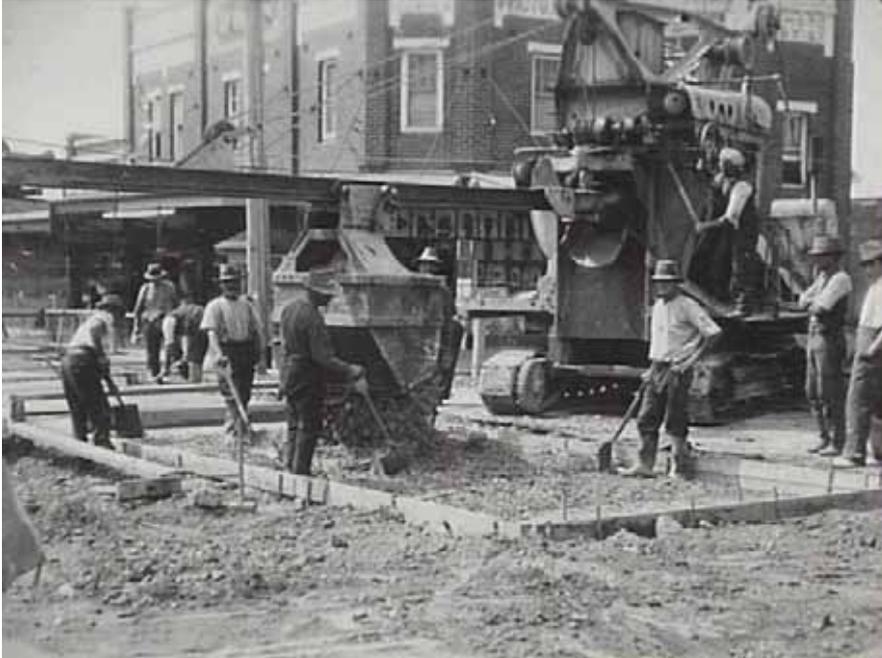
Figure 6-15: Lakemba c.1932, concreting Haldon Street. Source: Bankstown Library Collection via Pictorial Canterbury, item 020201.

Land values, however, rose dramatically after the construction of Lakemba Station, and shopfronts on Haldon Street were highly sought after by the mid-1920s (Figure 6-14). In 1932 the Chamber of Commerce (established in 1922), suggested that Haldon Street be concreted, as befitting its status as a busy commercial street (Figure 6-15).

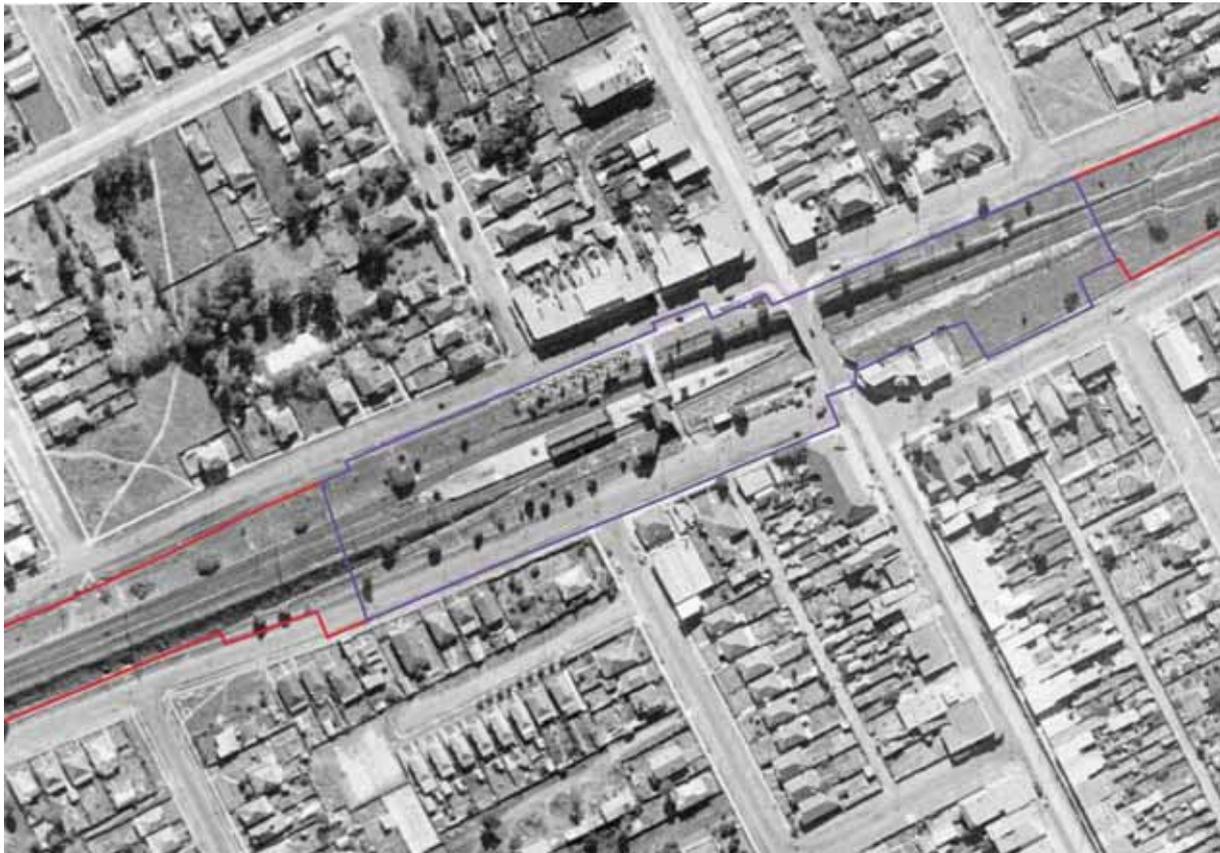
Figure 6-16: 1943 aerial of Lakemba Station. Source: SIX maps.

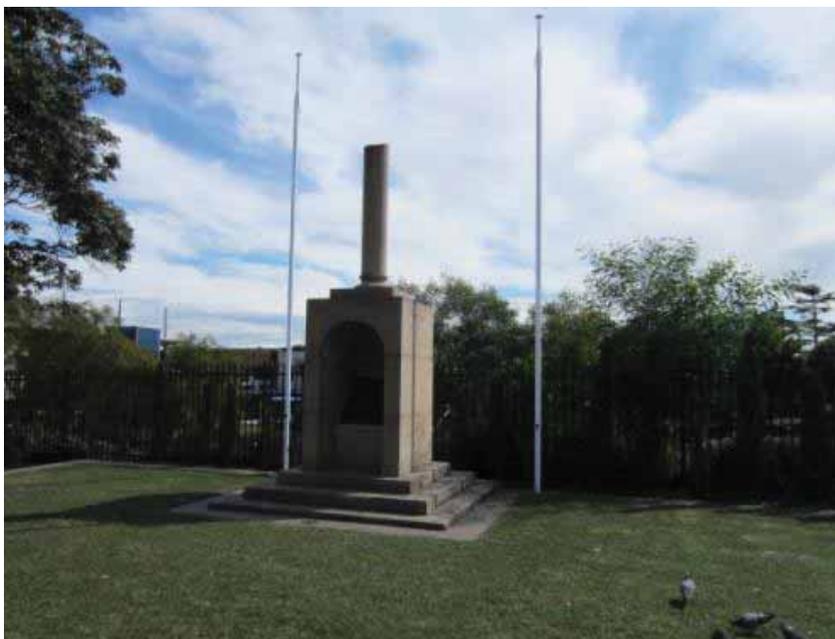
Figure 6-17: War Memorial at Lakemba Railway Station Group. Source: RailCorp.

A war memorial, consisting of a sandstone block on a plinth located in a small lawn area, was opened outside the station entrance on 19 April 1953 by State Governor John Northcott (Figure 6-17).⁶¹

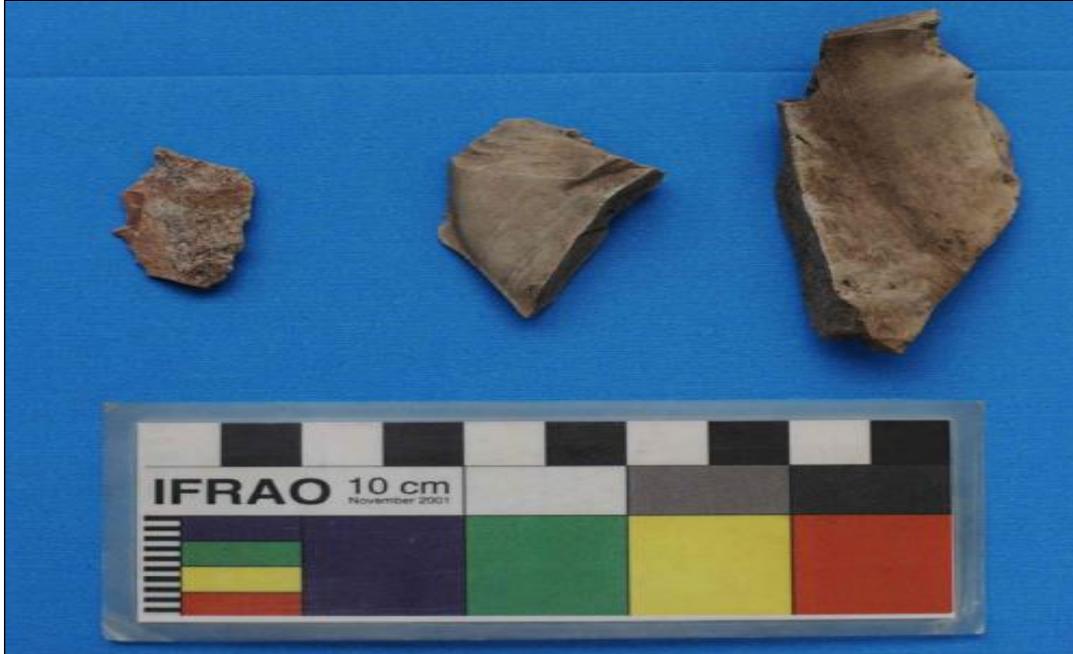
Photo 1 - Aboriginal artefacts found at the Wickham Transport Interchange, 2015

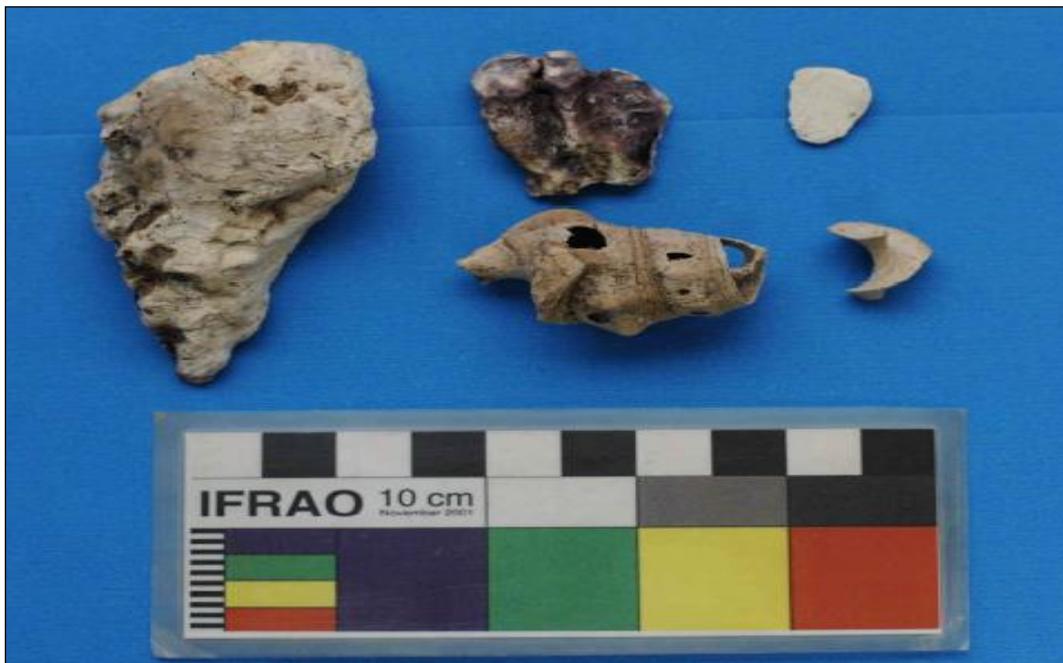
Photo 2 – Aboriginal artefacts (shell material) found at the Wickham Transport Interchange, 2015

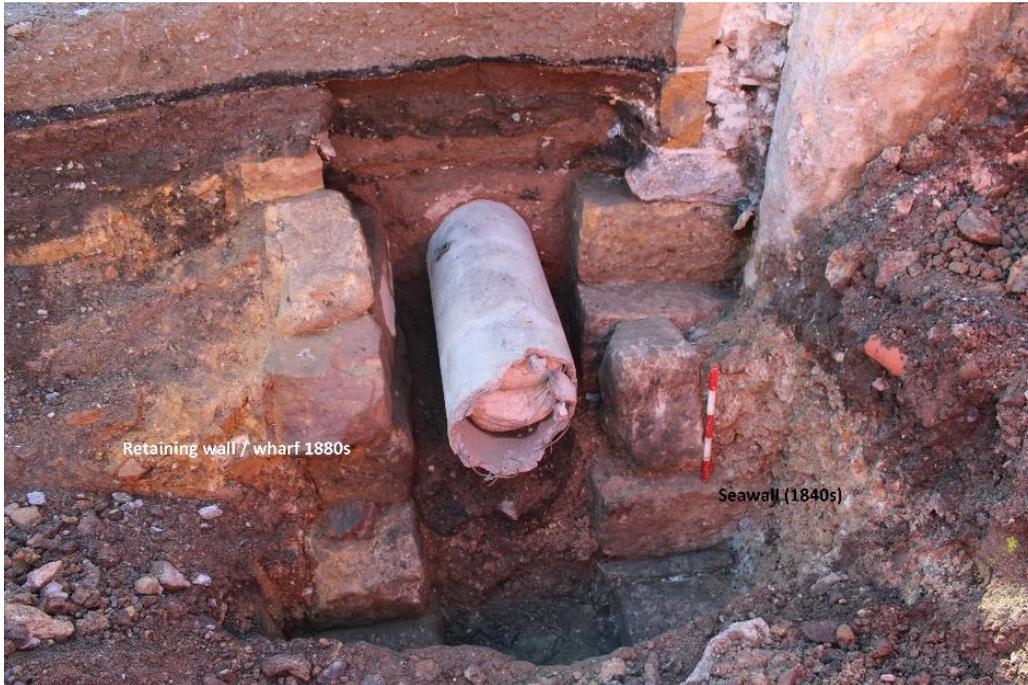
Photo 3 1840s seawall and 1880s retaining wall uncovered at Balmain East, 2016

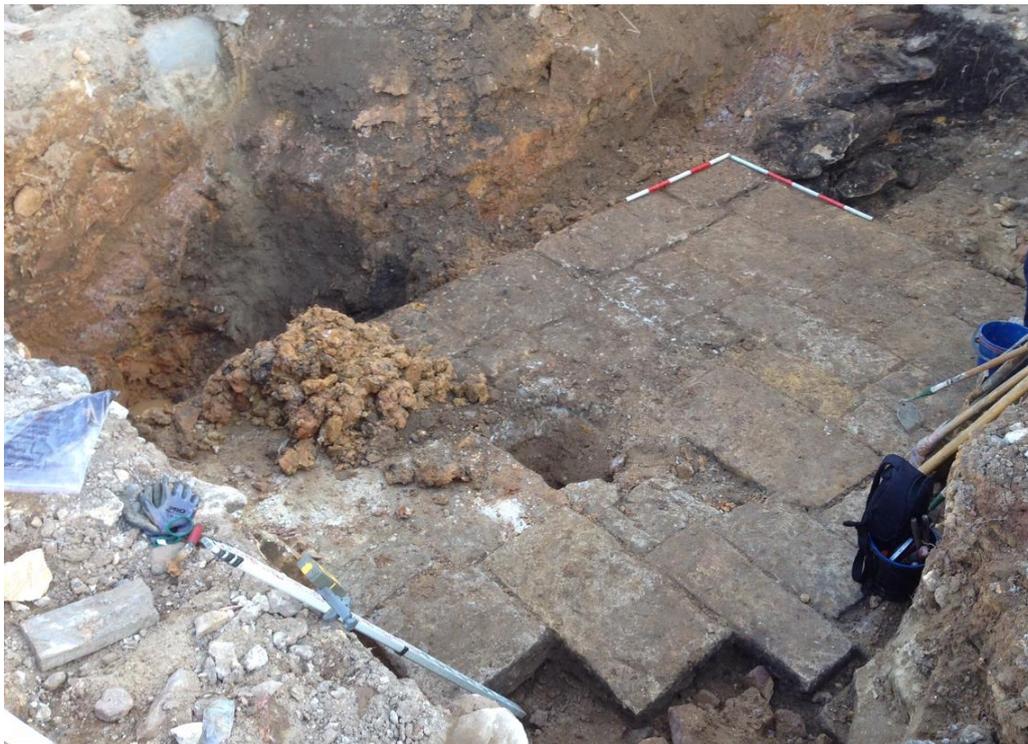
Photo 4 Sandstone pavers uncovered at Balmain East, 2016

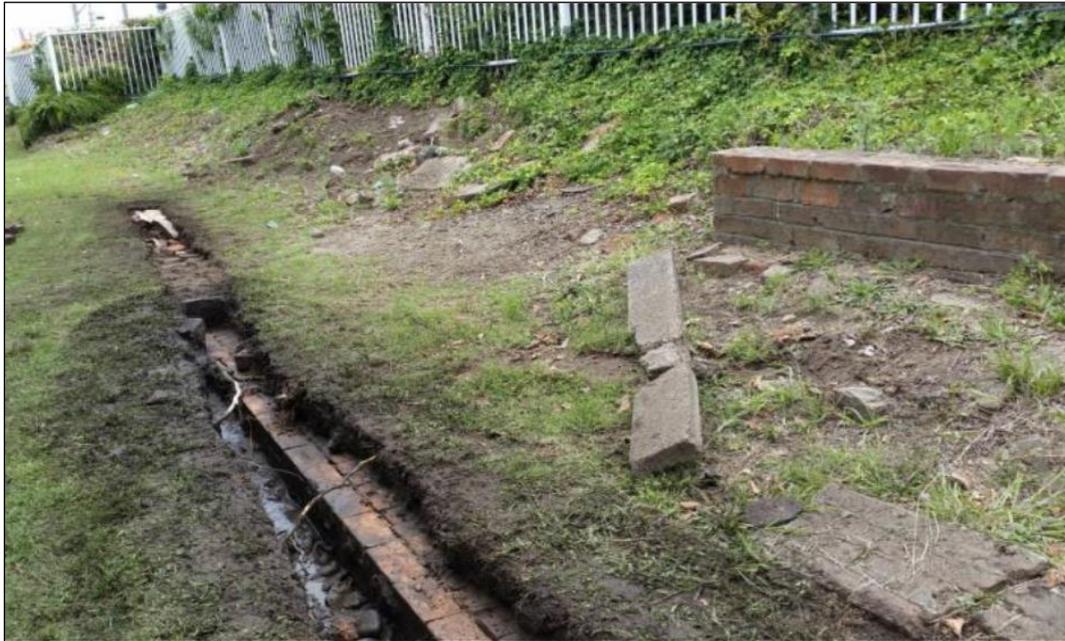
Photo 5 - Platform structure at Hamilton Railway Station classified as a 'work' by the project archaeologist - Wickham Transport Interchange project, 2015

Photo 6 - Platform structure at Hamilton Railway Station classified as a 'work' by the project archaeologist - Wickham Transport Interchange project, 2015

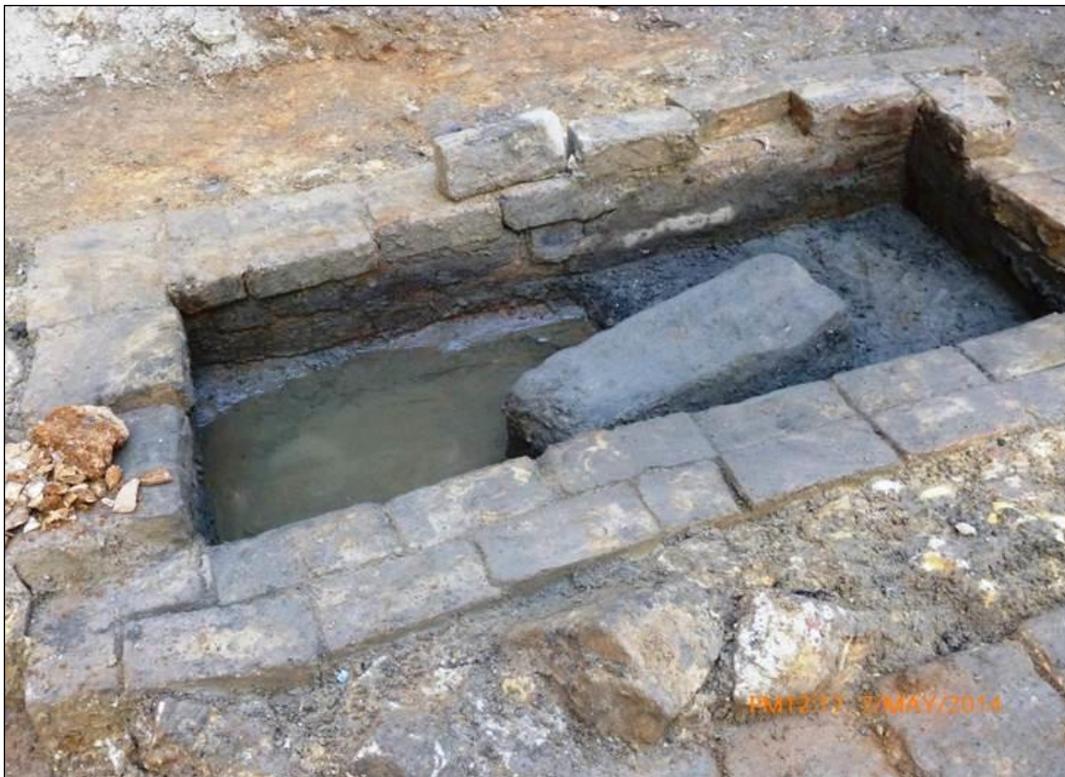
Photo 7 - Sandstone flagging and cesspit - Wynyard Walk project, 2014

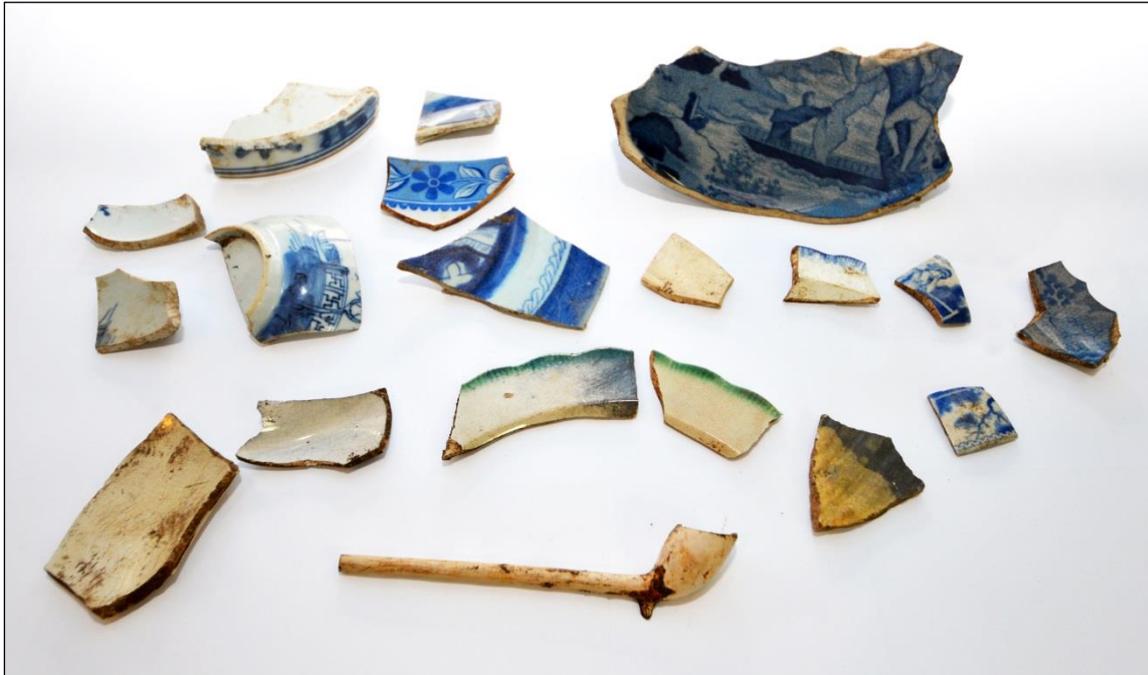
Photo 8 - Chinese Ming Dynasty pottery and English porcelain/pottery dating back to early 19th century - Wynyard Walk project, 2014

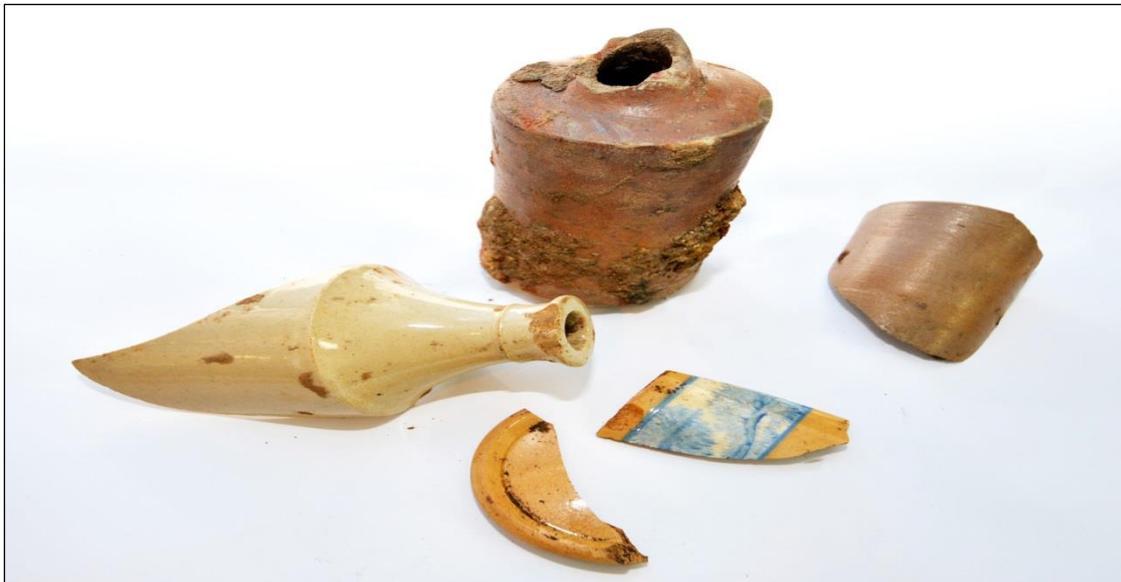
Photo 9 - Pottery made by convict potter Thomas Ball during the early settlement - Wynyard Walk project, 2014

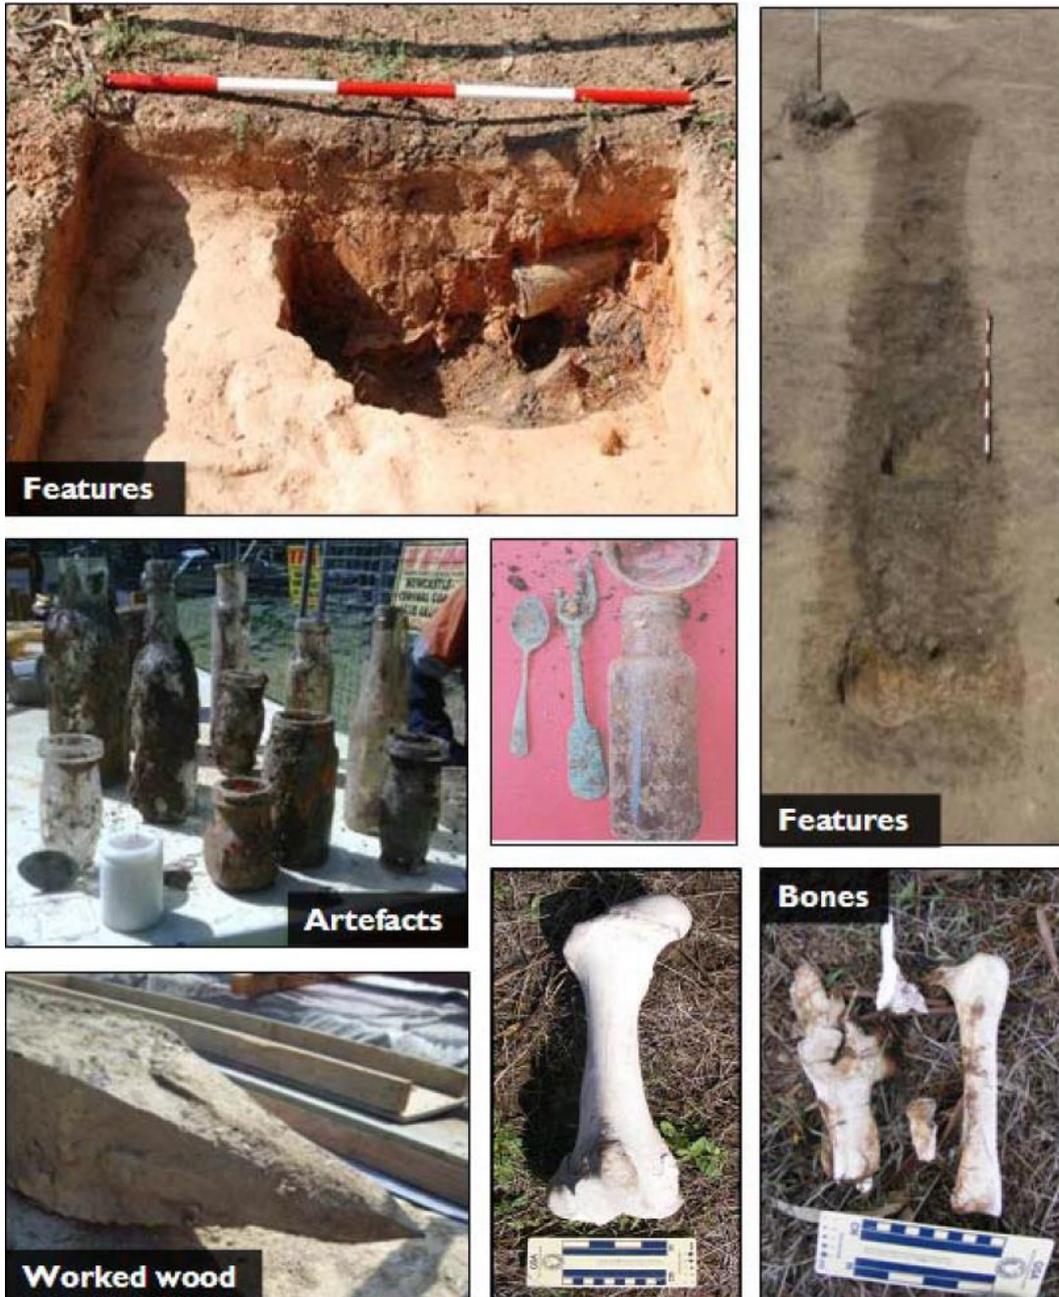
Photo 10 - Top left hand picture continuing clockwise: Stock camp remnants (Hume Highway Bypass at Tarcutta); Linear archaeological feature with post holes (Hume Highway Duplication), Animal bones (Hume Highway Bypass at Woomargama); Cut wooden stake; Glass jars, bottles, spoon and fork recovered from refuse pit associated with a Newcastle Hotel (Pacific Highway, Adamstown Heights, Newcastle area) (RMS, 2015).

The following images, obtained from the Roads and Maritime Services' *Standard Management Procedure for Unexpected Heritage items 2015*, can be used to assist in the preliminary identification of potential unexpected items during construction and maintenance works.

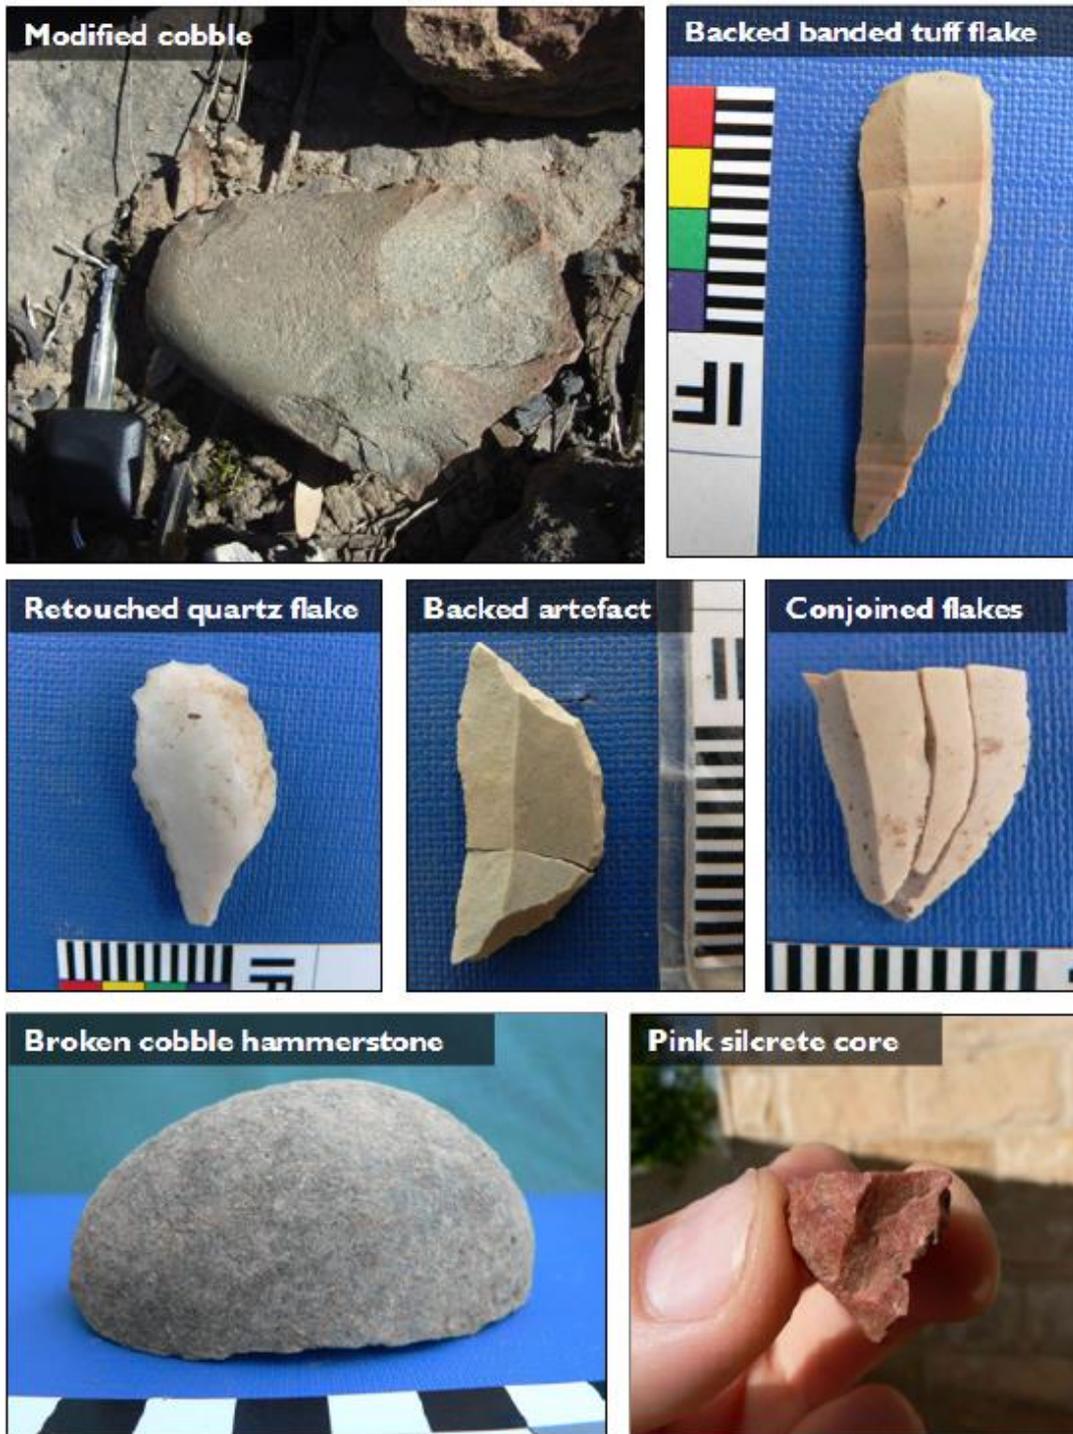
Photo 11 - Top left hand picture continuing clockwise: Stock camp remnants (Hume Highway Bypass at Tarcutta); Linear archaeological feature with post holes (Hume Highway Duplication), Animal bones (Hume Highway Bypass at Woomargama); Cut wooden stake; Glass jars, bottles, spoon and fork recovered from refuse pit associated with a Newcastle Hotel (Pacific Highway, Adamstown Heights, Newcastle area) (RMS, 2015).

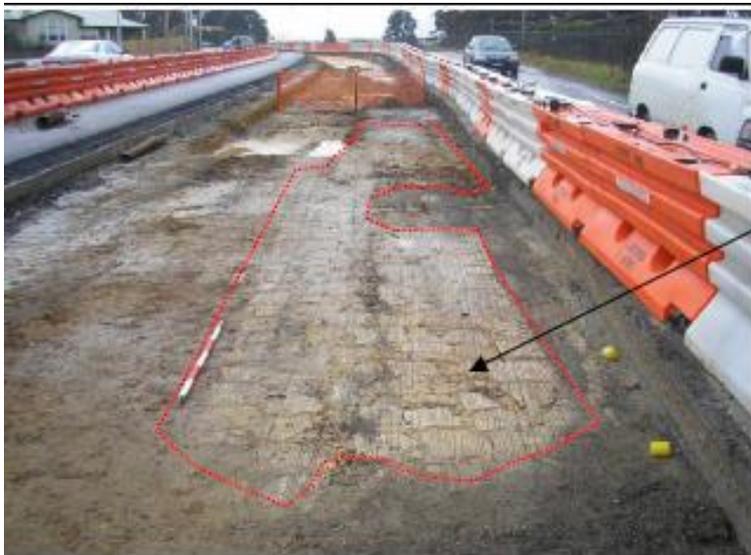
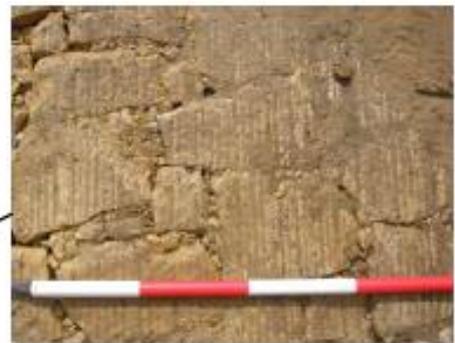
Figure 2: Close up detail of the sandstone surface showing material type, formation and construction detail. This is essential for establishing date of the feature.

Figure 1: Telford road uncovered on the Great Western Highway (Leura) in 2008 (RMS, 2015).

It is important to take a general photograph (Figure 1) to convey the location and setting of the item. This will add value to the subsequent detailed photographs also required (Figure 2).

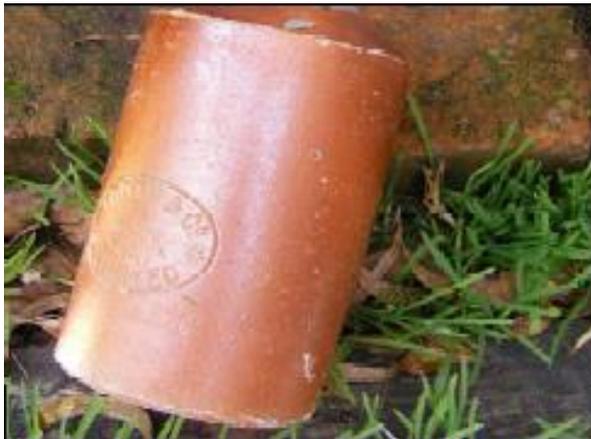
Figure 3: Ceramic bottle artefact with stamp.

Where unexpected items have a distinguishing feature, close up detailed photographs must be taken of these features, where practicable. In the case of a building or bridge, this may include diagnostic details architectural or technical features. See Figures 3 and 4 for examples.

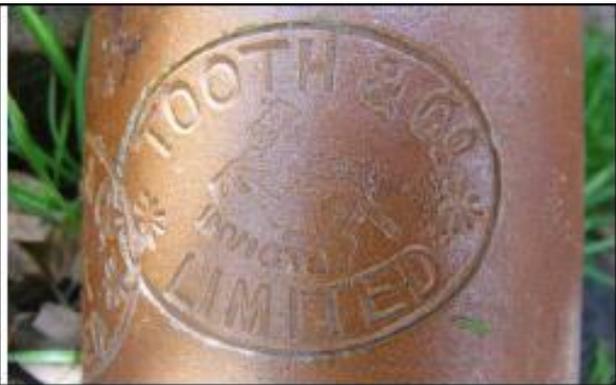
Figure 4: Detail of the stamp allows 'Tooth & Co Limited' to be made out. This is helpful to a specialist in gauging the artefact's origin, manufacturing date and likely significance.

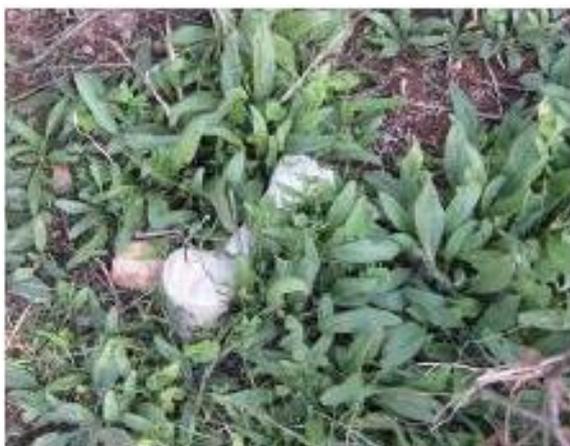
Figure 5: Bone concealed by foliage.

Ensure that photographs of bones are not concealed by foliage (Figure 5) as this makes it difficult to identify. Minor hand removal of foliage can be undertaken as long as disturbance of the bone does not occur. Excavation of the ground to remove bone(s) should not occur, nor should they be pulled out of the ground if partially exposed.

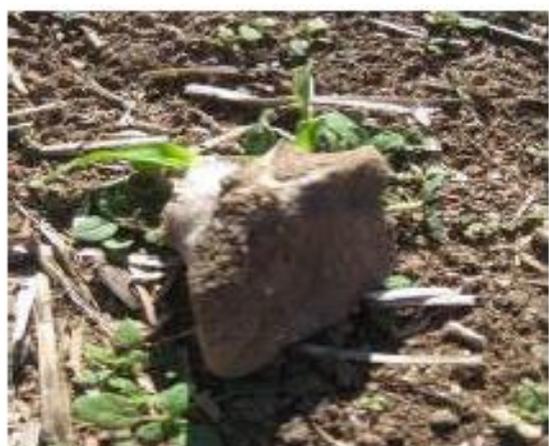
Figure 6: Bone covered in sediment

Where sediment (adhering to a bone found on the ground surface) conceals portions of a bone (Figure 6) ensure the photograph is taken of the bone (if any) that is not concealed by sediment.

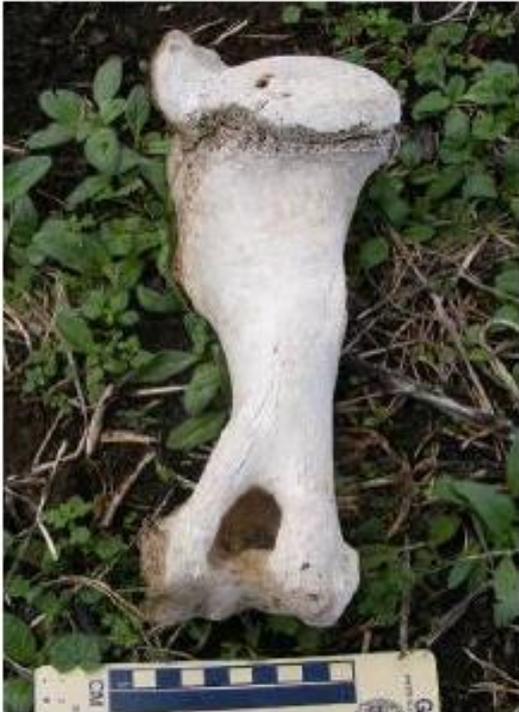
Figure 7: Photograph showing complete bone.

Ensure that all close up photographs include the whole bone and then specific details of the bone (especially the ends of long bones, the *epiphysis*, which is critical for species identification). Figures 7 and 8 are examples of good photographs of bones that can easily

be identified from the photograph alone. They show sufficient detail of the complete bone and the epiphysis.

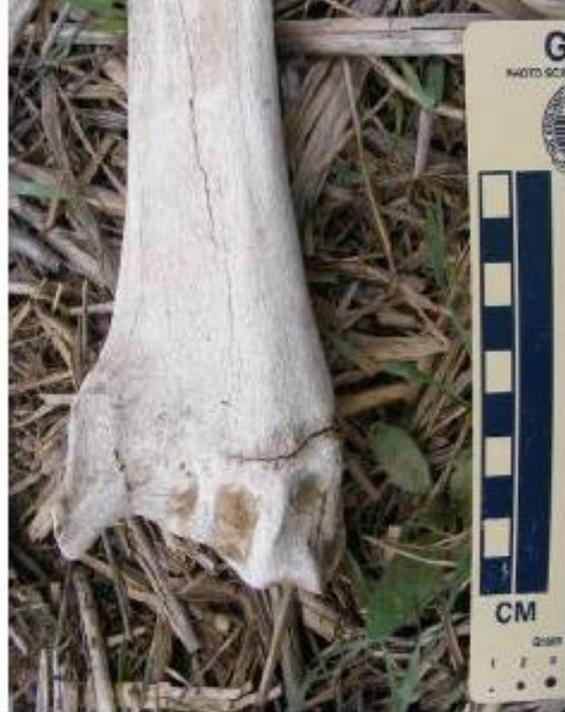
Figure 8: Close up of a long bone's epiphysis.

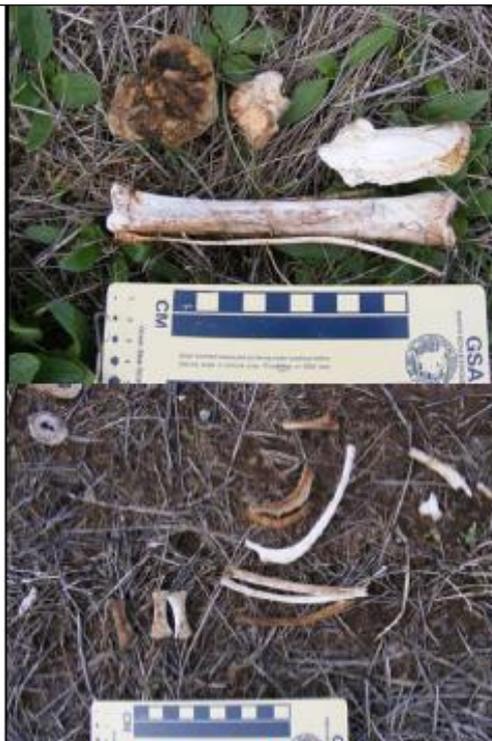
Figure 2: Disarticulated bones that require assessment to determine species.

Where it is not immediately obvious that the bones are human (in the majority of cases, illustrated by Figure 2), specialist assessment is required to establish the species of the bones. Photographs of the bones can assist this assessment if they are clear and taken in accordance with guidance provided in Appendix 3. Good photographs often result in the bones being identified by a specialist without requiring a site visit; noting they are nearly always non-human. In these cases, non-human skeletal remains must be treated like any other unexpected archaeological find.

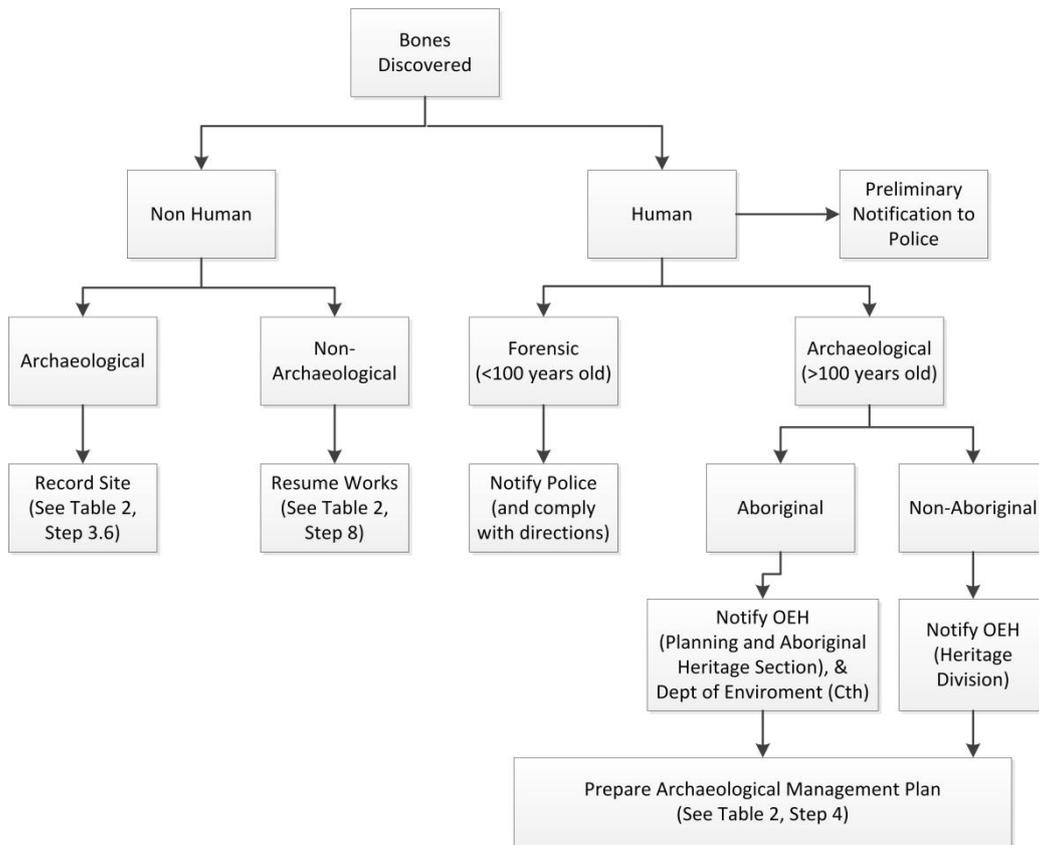
Figure 3 Overview of steps to be undertaken on the discovery of bones

Figure 3 summarises the notification pathways on finding bones.
