ARBORICULTURAL IMPACT ASSESSMENT & TREE PROTECTION PLAN

Rail Corridor and Broughton Street Canterbury Station - Southwest Metro Upgrade Version 8

Prepared for: HSEJV

7 June 2022

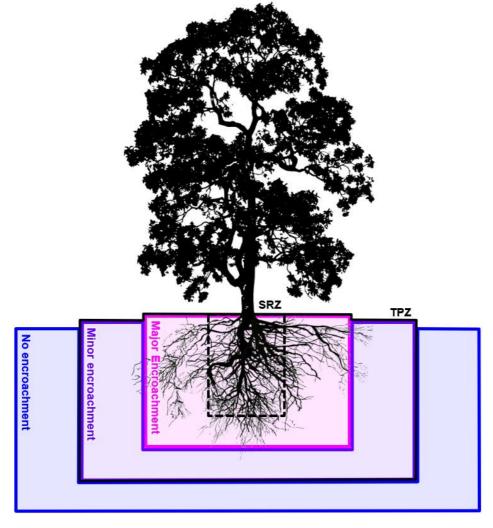
Figure 1: Three (3) levels of encroachment

Encroachment within the TPZ is acceptable, providing that the arborist can demonstrate that the tree will remain viable. There are three (3) levels of encroachment (as defined by AS 4970-2009):

- No encroachment (0%): No encroachment within the TPZ.
- Minor encroachment (<10%): The encroachment is less than 10% of the TPZ.
- Major encroachment (>10%): The encroachment is greater than 10% of the TPZ.

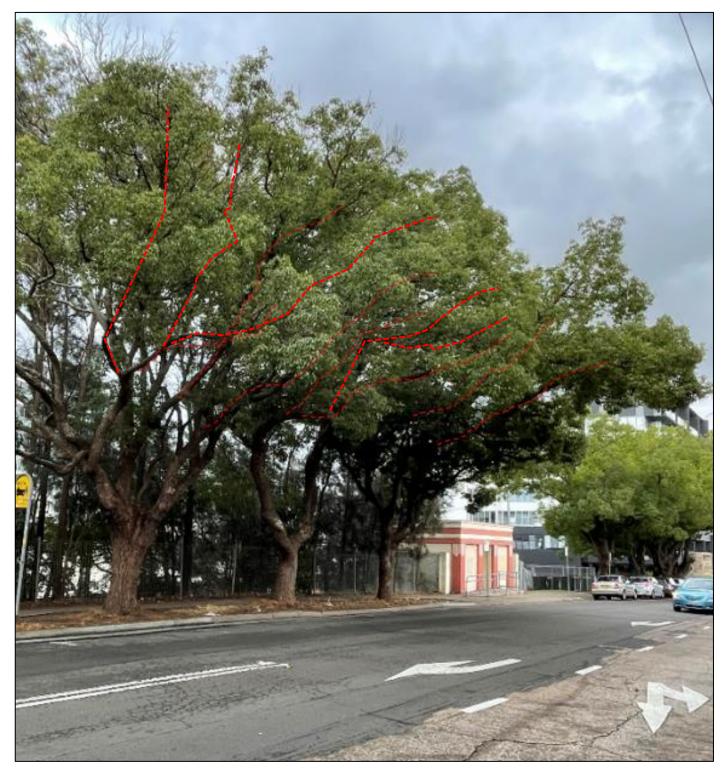
Figure 1: Approximate pruning required to establish crane clearance.

- **Prune:** A total of **3** trees **(Tree 595, 596, 597)** will be subject to a canopy encroachment of approximately 40%. The pruning is required to establish clearances for crane operation. Several mitigation measures are outlined in **Chapter 6** to reduce potential impacts on trees.
- Remove: A total of 17 trees (Tree 1, 2, 3, 4, 5, 6, 10, 11, 12, 13, 14, 15, 16, 603, 726, 727, 728) and 1 group of vegetation (G725) will be subject to an encroachment of greater than 20% within the TPZ. Encroachment of greater than 20% (of the total TPZ area) can begin to impact the structural root zone (SRZ) and is generally more difficult to mitigate. Impacts within the SRZ are not recommended as it may lead to the destabilisation and/or decline of the tree. These trees are located within, or directly adjacent to the proposed construction footprint and cannot be retained under the current proposal.

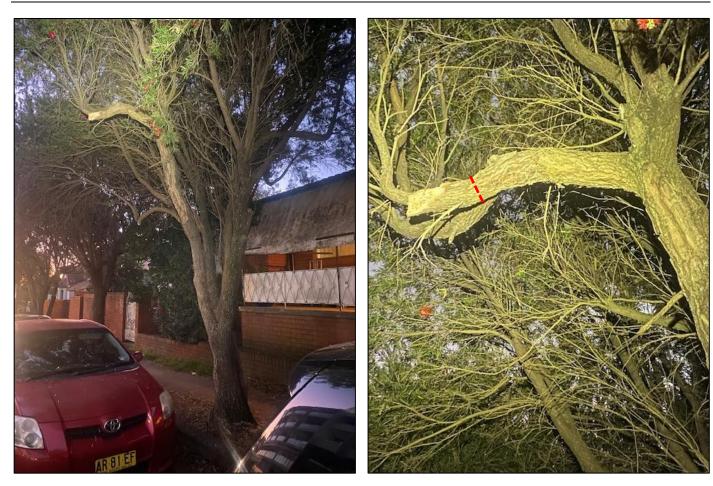
Figure 8: The subject tree (Tree 17)

Figure 9: Pruning location (Tree 17)
