ARBORICULTURAL IMPACT ASSESSMENT & TREE PROTECTION PLAN

Marrickville Station - Southwest Metro Upgrade Construction Report

Version 6

8 July 2022

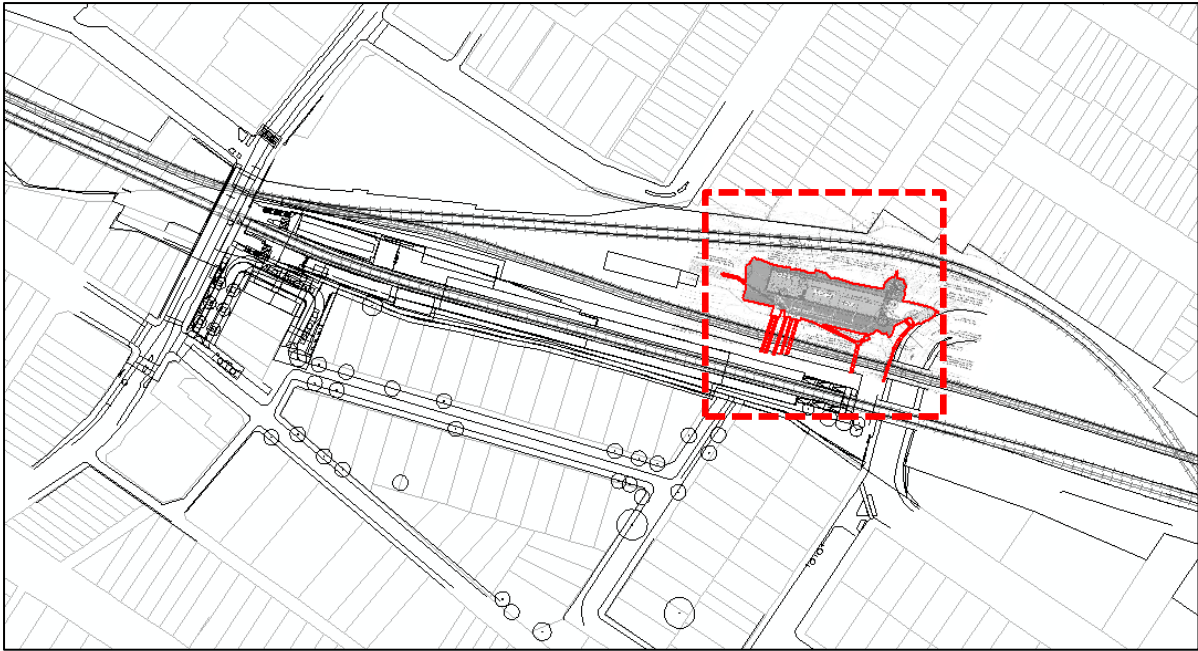
Figure 1: Location of the proposed MSB

Specifically, this document refers to the impacts associated with trees for the Metro Services Building (MSB) at Marrickville (refer to figures on next page):

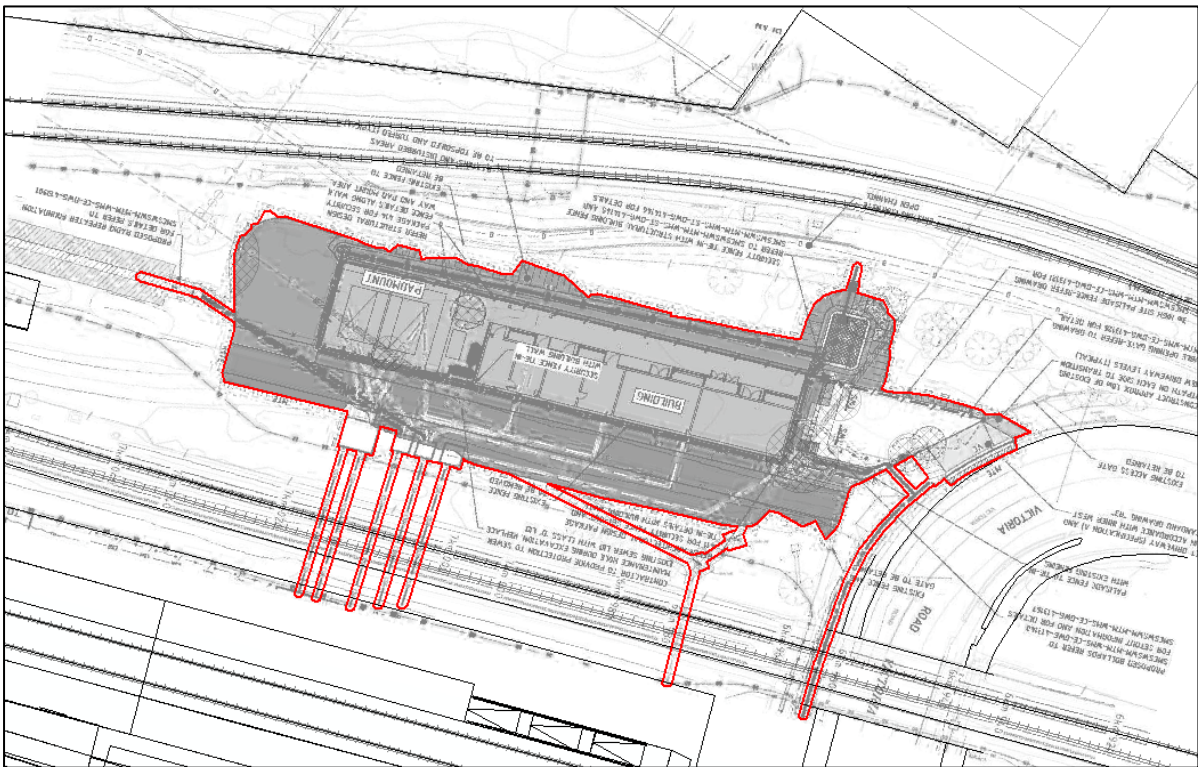
Figure 2: Closer view of the MSB

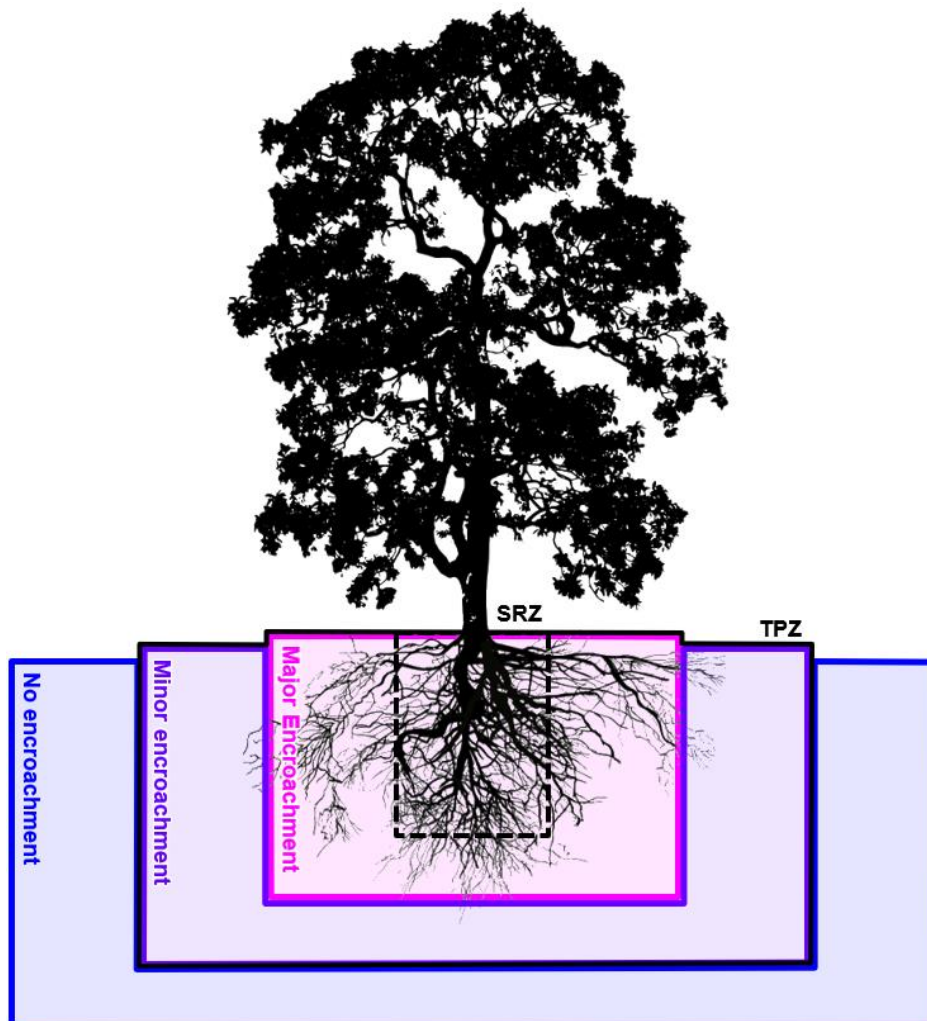
Figure 1: Three (3) levels of encroachment

- **No encroachment (0%):** No encroachment within the TPZ.
- **Minor encroachment (<10%):** The encroachment is less than 10% of the TPZ.
- **Major encroachment (>10%):** The encroachment is greater than 10% of the TPZ.

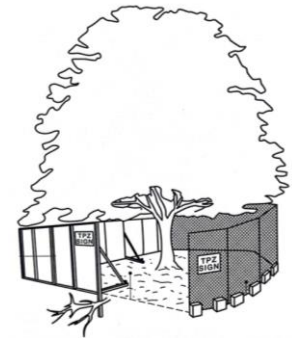
- Temporary mesh panel fencing (minimum height of 1.8m).
- Installed prior to site establishment and remain intact until the completion of works.
- Protective fencing must not be removed or altered without the approval of the project arborist.
- Prominently signposted with 300mm x 450mm boards stating, "NO ACCESS - TREE PROTECTION ZONE."
- Certified and inspected by the project arborist.

Tree protection fencing must be established at the locations shown in the tree protection plan. Existing fencing, site hoarding, or structures (such as a wall or building) may be used as tree protection fencing, providing the TPZ remains isolated from the construction footprint. Tree protection fencing must be installed prior to site establishment and remain intact until the completion of works. Once erected, protective fencing must not be removed or altered without the approval of the project arborist. Specifications for the tree protection fencing are as follows:

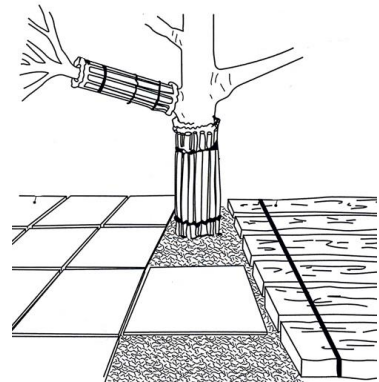
- A thick layer of carpet underfelt, geotextile fabric, or similar wrapped around the trunk to a minimum height of 2m.
- 1.8m lengths of softwood timbers aligned vertically and spaced evenly around the trunk (with a small gap of approximately 50mm between the timbers).
- The timbers must be secured using galvanised hoop strap (aluminium strapping).

The timbers shall be wrapped around the trunk but not fixed to the tree, as this will cause injury/damage to the tree.

Where the provision of tree protection fencing is impractical or must be temporarily removed, trunk protection shall be installed to avoid accidental mechanical damage.

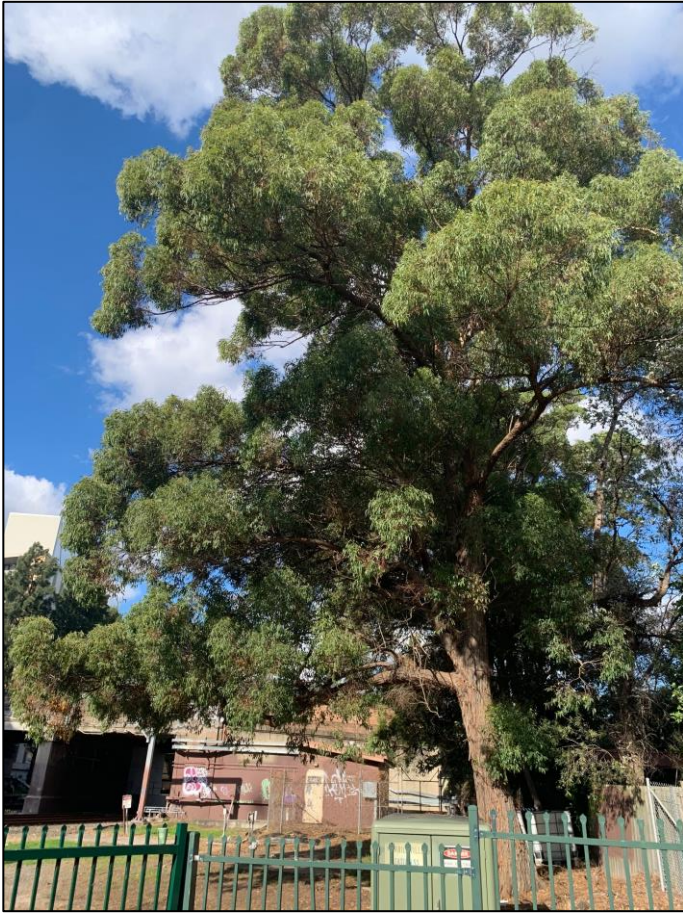
Figure 1: The subject tree (Tree 3276)

Id.	Botanical name	Encroachment	% Encroachment within TPZ	Description of impacts	Considerations and restrictions	Result
3276	<i>Eucalyptus microcorys</i>	Minor	5%	<ul style="list-style-type: none"> - A single low-hanging branch is restricting access to plant and machinery (13T excavator, piling rig, and mobile crane). - Branch is within the mobile crane operating radius during the OLX bridge construction. - General access and moveability are restricted. - The GST works would be impacted by the lack of space and low clearance of the tree. - Civil access route would be impacted, and the CSR trench could also be impacted if there are delays for hydrema access, etc - Piling excavator could be delayed due to access issues and restrict the ability to work the pile on the up line could be impacted due to the lack of space and low clearance of the tree branch. 	<ul style="list-style-type: none"> - No other options available - No alternative locations as the Wooley lane access cannot be blocked 	Prune

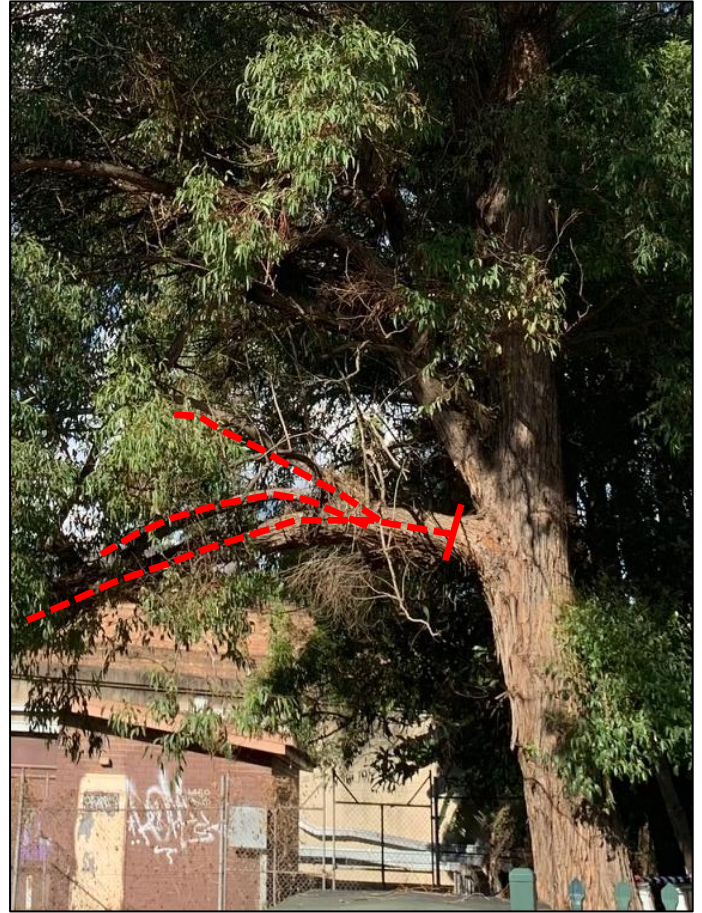
Figure 2: Pruning location (Tree 3276)

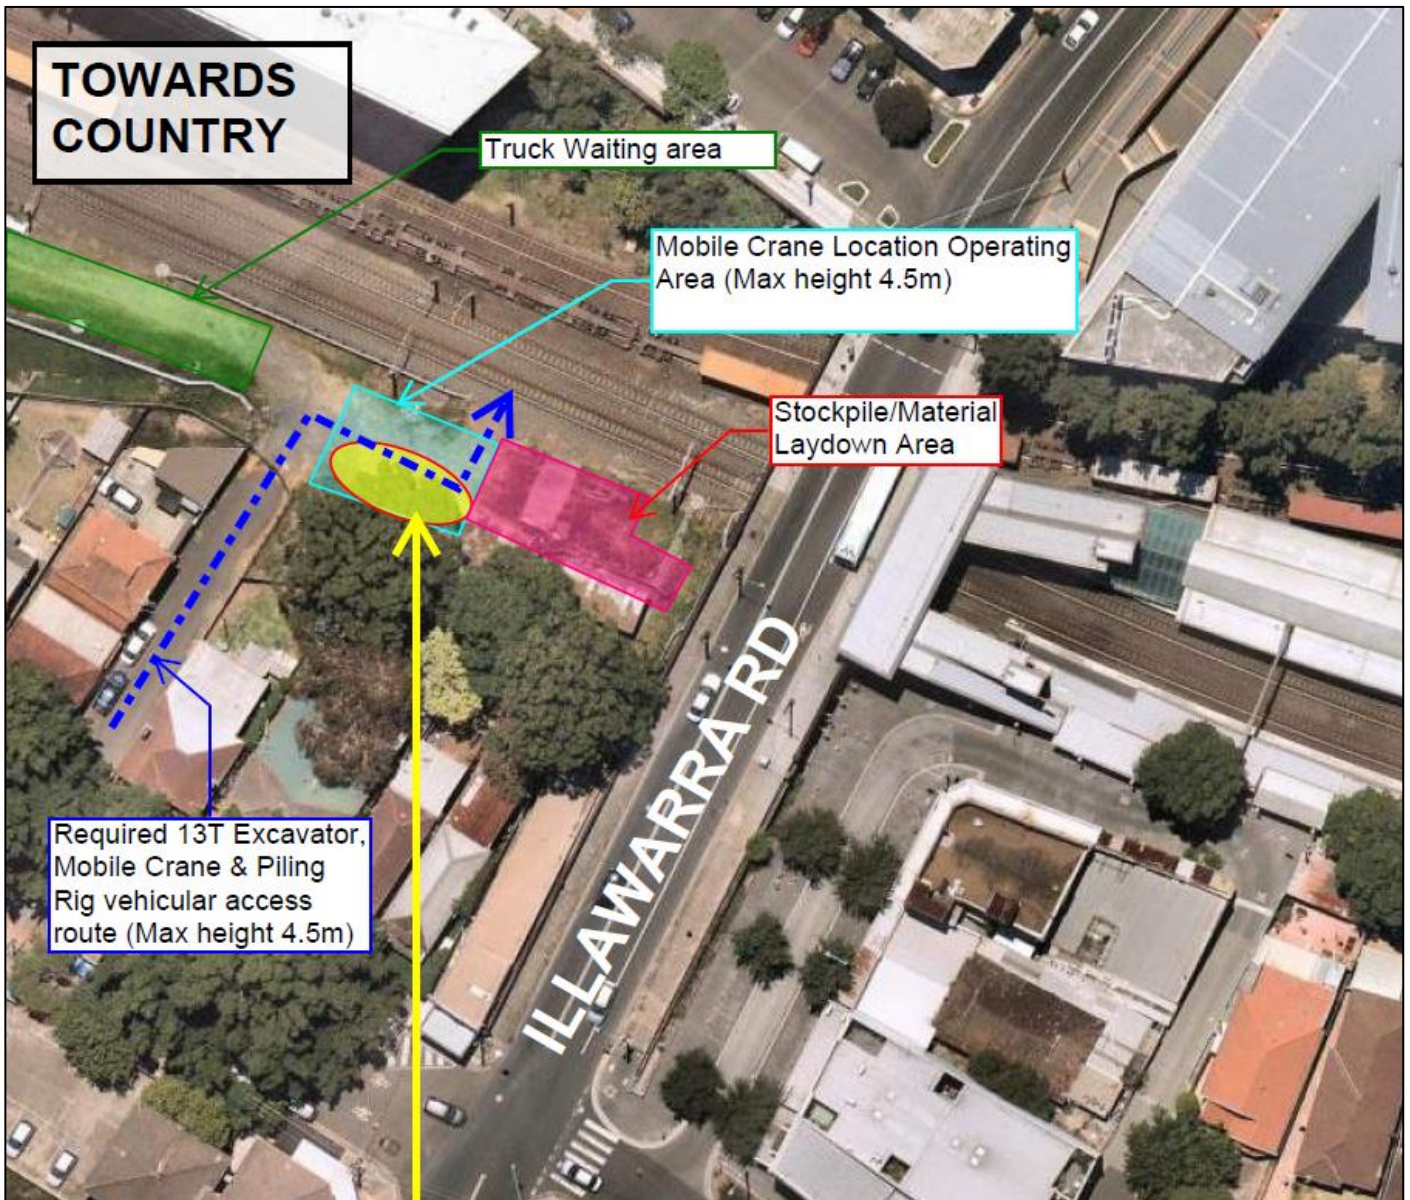
Figure 3: Reason for pruning, the location of the Tree 3276 is shown in **YELLOW**.

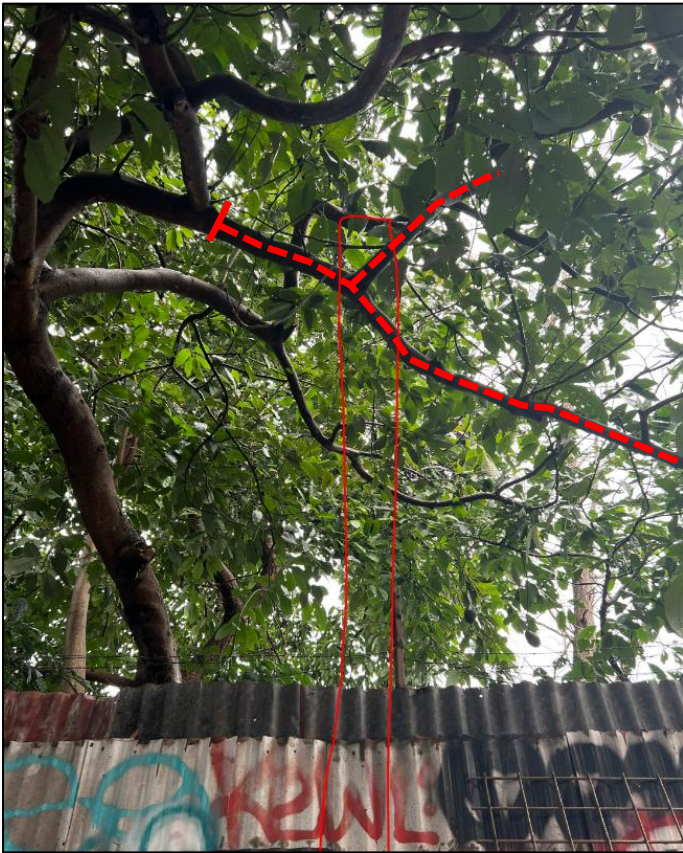
Figure 4: Pruning location (Tree 3278)

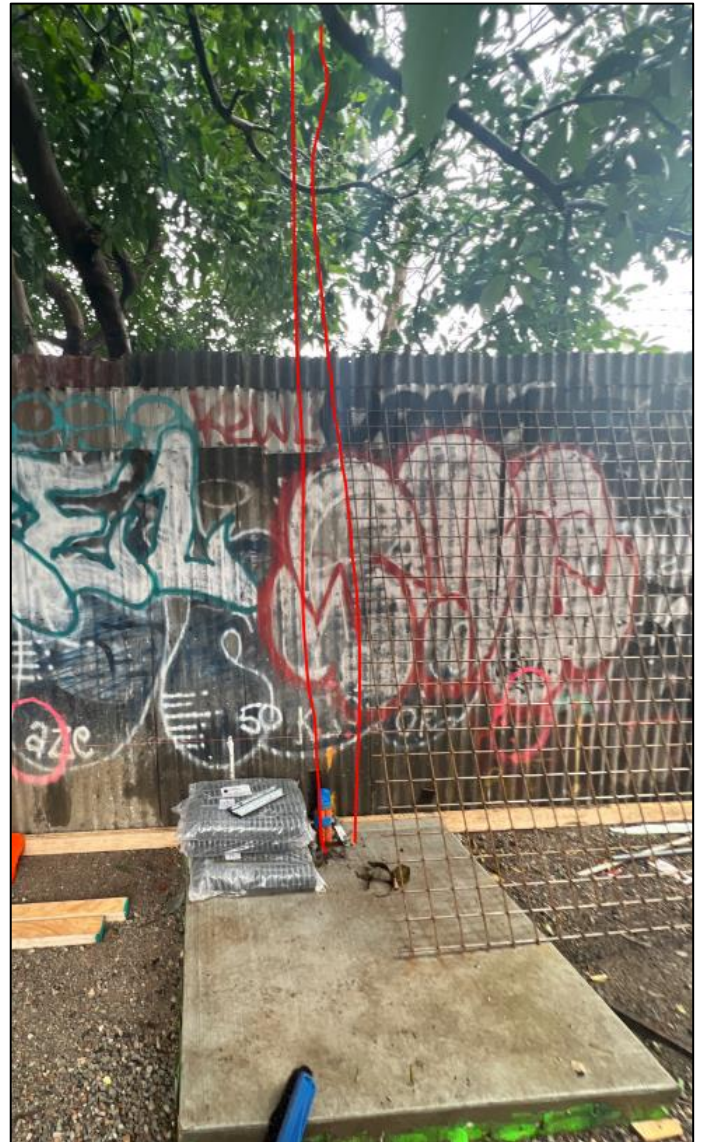
Figure 5: Light post location (Tree 3278)
