# Canterbury Station Catchment and Construction Site

Archaeological method statement

Prepared for HSEJV May 2021

Report Number		
J210114 RP#2		
Client		
HSEJV		
Date		
17 May 2021		
Version		
v3 Final		
Prepared by	Approved by	
Hollana	Jun Luly

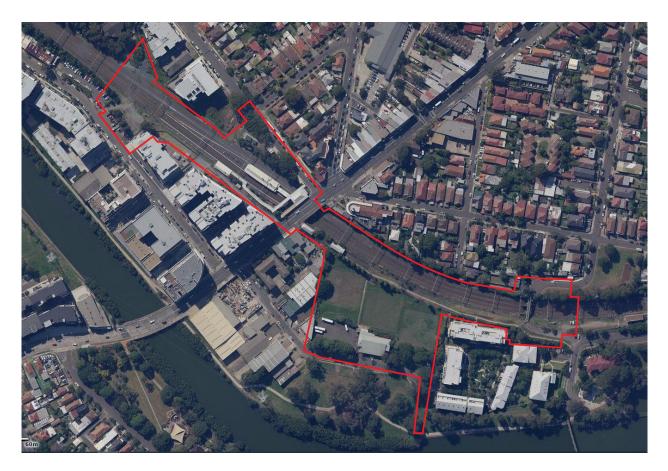
Plate 1.1 The Canterbury Station Catchment project area. Source: Sixmaps 2021.

This AMS has been prepared to guide the management of archaeological resources in the construction impact zones identified in this report (Plate 1.1). It is a response to the 'Revised Mitigation Measures' in the *Sydney Metro City & Southwest Sydenham to Bankstown Upgrade – Submissions and Preferred Infrastructure Report*, (nd) approved by the Department of Planning Industry and Environment (DPIE). Specifically, Condition NAH12 which states that:

The location of the project area is shown in Plate 1.1. The areas of archaeological potential, as identified by the AARD, are overlaid on the civil drawings are shown in Plate 3.3.

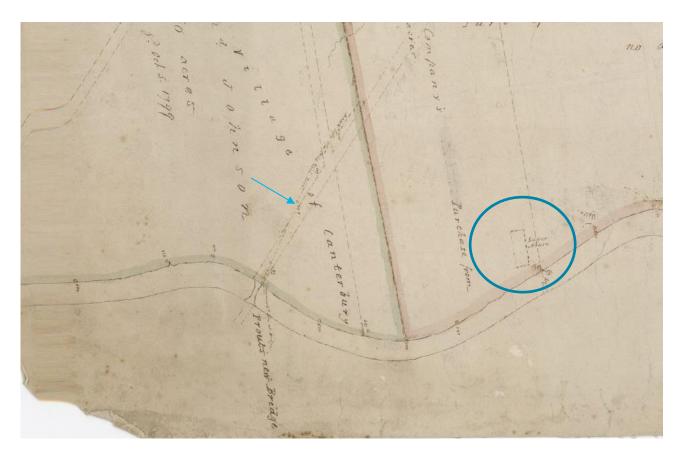
Plate 1.2 Detail from an undated plan of the Canterbury Estate showing the outline of the 'Sugar House' circled blue (Source: Manuscript cadastral map, NLA).

Plate 1.2 is a detail from an undated map of the Canterbury Estate (*Manuscript cadastral map of allotments along the Cook's River near the village of Canterbury, New South Wales*) from the State Library of NSW. As shown by this map, Prouts Bridge had been constructed, represented as a solid line, and is labelled as "Prouts new bridge". The line of what is now Canterbury Road is dashed (blue arrow) suggesting that it had been surveyed but not formalised. To the right (east), the dashed lines of the "Sugar House" are visible but other buildings on this map are shown with solid lines and labelled (Plate 1.3) suggesting the 'Sugar House' may have been planned but not constructed. The map shows the plans for the road and for the Works (referred to by various names – refer to paragraph below). This information would date this plan to just before 1841 when the mill was built, and the village sprung up around it. No structures are shown in the project area to the east of the road alignment.

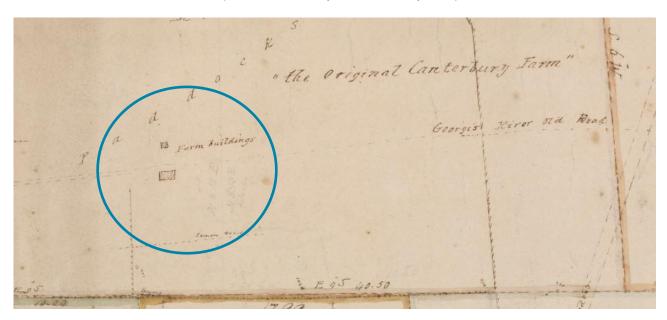
Plate 1.3 Detail from another section of the Manuscript cadastral map, with drawings of existing farm buildings drawn with solid lines (circled blue). (Source: Manuscript cadastral map, NLA)

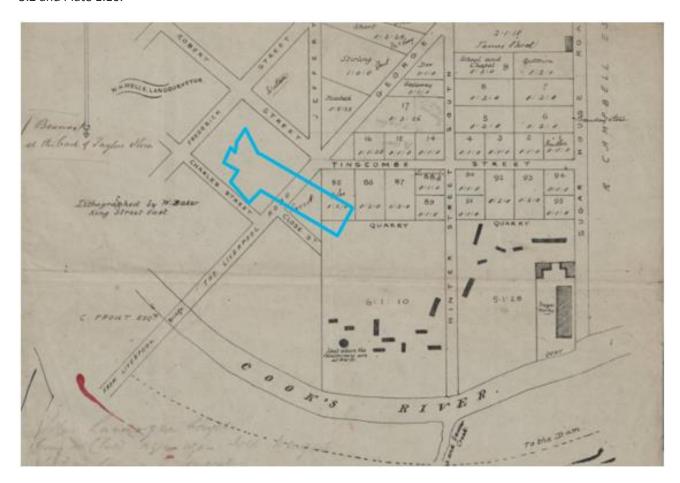
Plate 1.4 W.E. Wells c.1841 Plan of 95 allotments at Canterbury adjoining the Australasian Sugar Company's works. Approximate boundary of the project area outlined in blue (Source: National Library of Australia)

The area of the rail corridor located within the boundary of the Sugar Works encompasses an area between Tincombe Street to the north and Close Street to the south. The 1841 W H Wells survey plan (Plate 1.4) illustrates the subdivided Lots 85 to 89 fronted Tincombe Street in this area, with the "quarry" to the south. Lot 85 is noted to have been purchased by an individual named 'Poles'. A triangular block to the west, fronting 'George Street/The Liverpool Road' (now Canterbury Road), which is not numbered is within the project area and was owned by 'Garrett'.

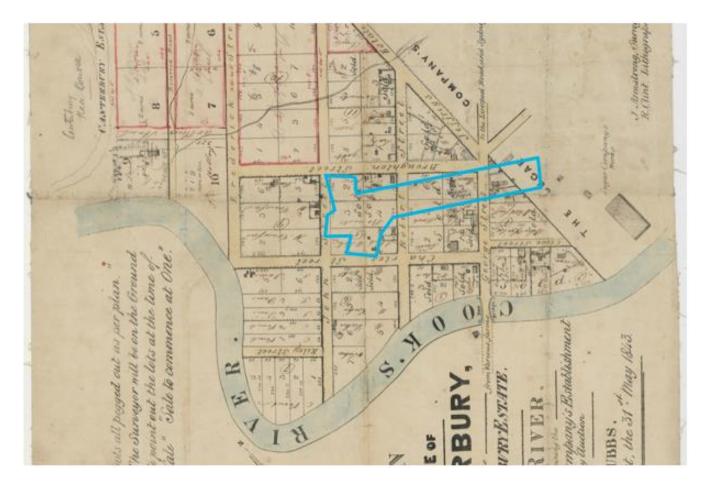
Plate 1.5 Plan of the Village of Canterbury, May 1843. Approximate boundary of the project area outlined in blue (Source: SLNSW, M Z/M2 811.1829/1843/1).

Plate 1.5 is a detail of the plan of the village of Canterbury, part of the Canterbury Estate on Cook's River immediately adjoining the Australian Sugar Company's establishment to be sold by auction by Mr. Stubbs, on Wednesday next, the 31st. May 1843 (source State Library NSW M Z/M2 811.1829/1843/1). Refer also to Section 3.2 and Plate 1.10.

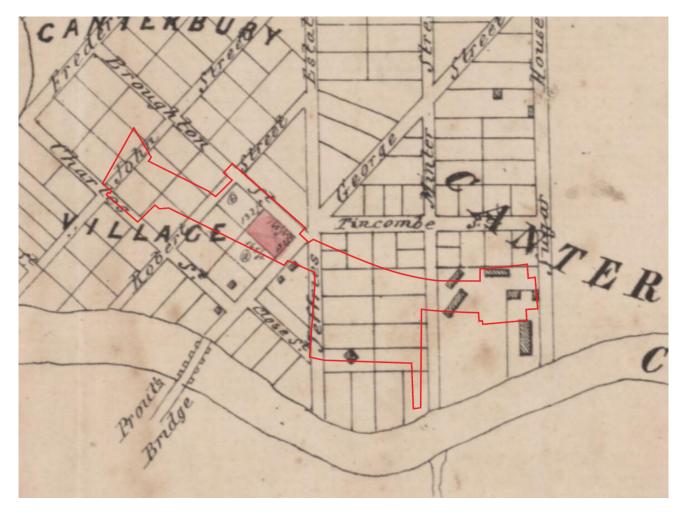
Plate 1.6 The project boundary over a detailed section of the 1859 plan of the Canterbury estate and village (Source: NLA, MAP F 322).

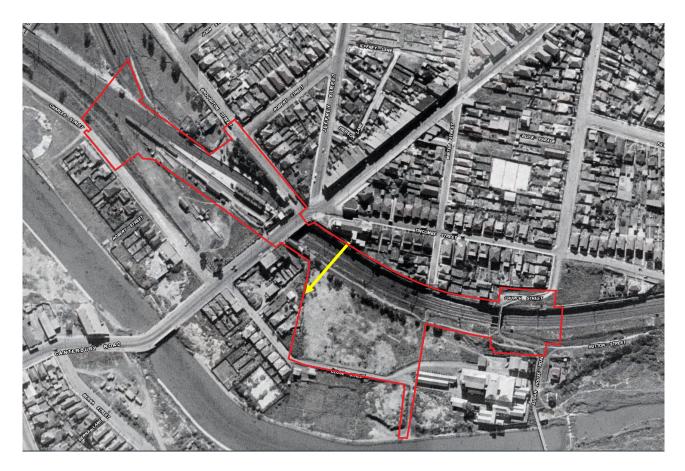
Plate 1.7 The project area overlaid on the 1943 aerial photograph of Sydney. Note: the early boundary line of the sugar works is indicated by a yellow arrow (Source: Sixmaps).

Urban growth in Canterbury was rapid from 1943 onwards (Plate 1.7). The industrial buildings that originally began as the Australian Sugar Company had fallen into disuse and surrounding buildings between the Cooks River and Close Street had been cleared and grassed. Small to medium sized warehouses were built and are now being replaced by apartment blocks.

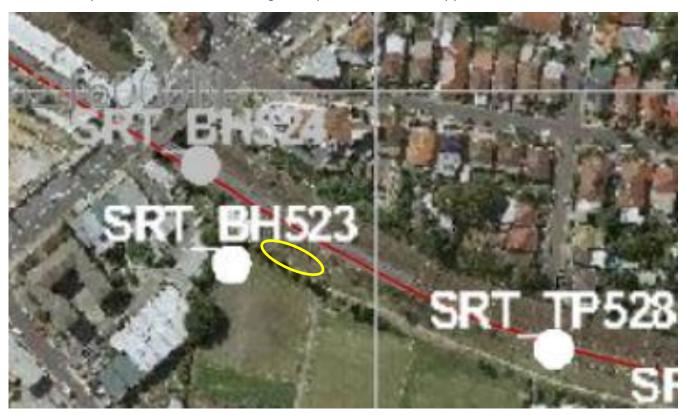
Plate 1.8 The location of SRT BH523 on an aerial photograph. The estimated location of the proposed GST fencing is circled yellow (Source: Metron T2M 2019, p.57).

Geotechnical information for the project area was interpreted from various sources (Parsons Brinckerhoff *et al* in Metron T2M internal technical memorandum 2019). The data from the Metron report has been extrapolated for this report, as testing was not completed specifically in the area of the proposed GST fencing, which is an area of interest in this AMS. The detail from SRT BH523, located in the former bowling club grounds approximately 11 m south and 40 m west of the area of interest (Plate 1.8), indicates that the general area has a shallow (approximately 450 mm thick) layer of fill above Hawkesbury Sandstone (Parsons Brinkerhoff *et al* in Metron T2M, p.57 and Plate 1.9).

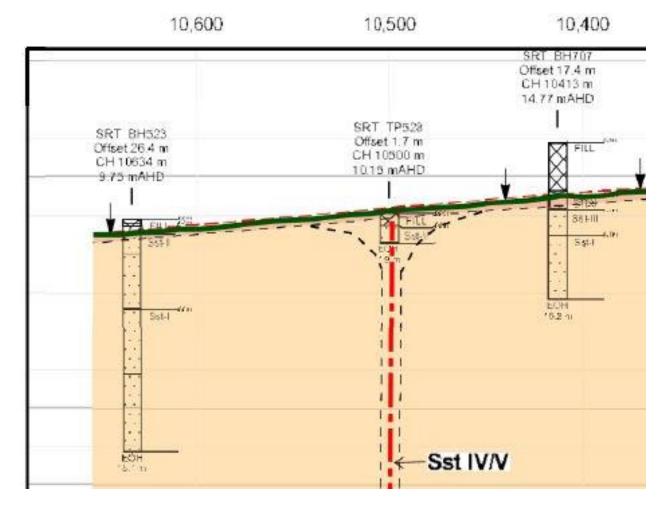
Plate 1.9 Schematic representation of the geotechnical results in the area closest to the proposed GST fencing (Source: Metron T2M 2019, p.57).

A combination of test pits and boreholes in the rail cutting indicates that the most dominant material before the natural sandstone, is ballast, and that the platforms are fill with gravelly clay with inclusions such as gravel, brick and concrete fragments (see Metron T2M 2019: pp 95-104). The platform fills vary between silty, sandy gravel to fine clayey sandy gravel but are essentially materials used to build up the platforms. Fill has been deposited in voids created in the platforms at various times and, as evidenced by the survival of the nineteenth century pier footings uncovered during WE38 (WE38 Canterbury Summary EMM 2021), it is possible that historical features were left in situ where they did not interfere with the design and operations of the railway platform.

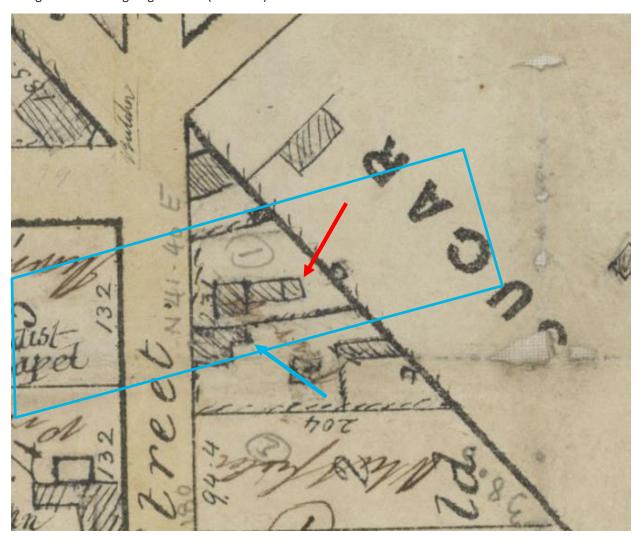
Plate 1.10 Detail of the 1843 plan of the Village of Canterbury on the eastern side of Canterbury Road.

The red arrow points to a structure removed by the rail cutting; the blue arrow indicates a structure on what remains natural ground level (State Library of NSW).

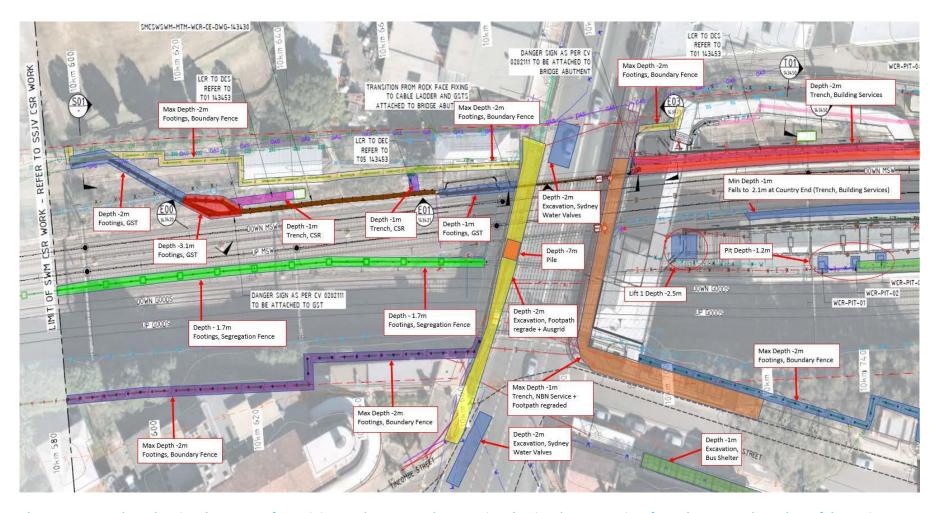
Plate 3.1 Plans showing the extent of remaining works at Canterbury Station that involve excavation, from the eastern boundary of the project to part-way through the railway station (Source: HSEJV 2021)

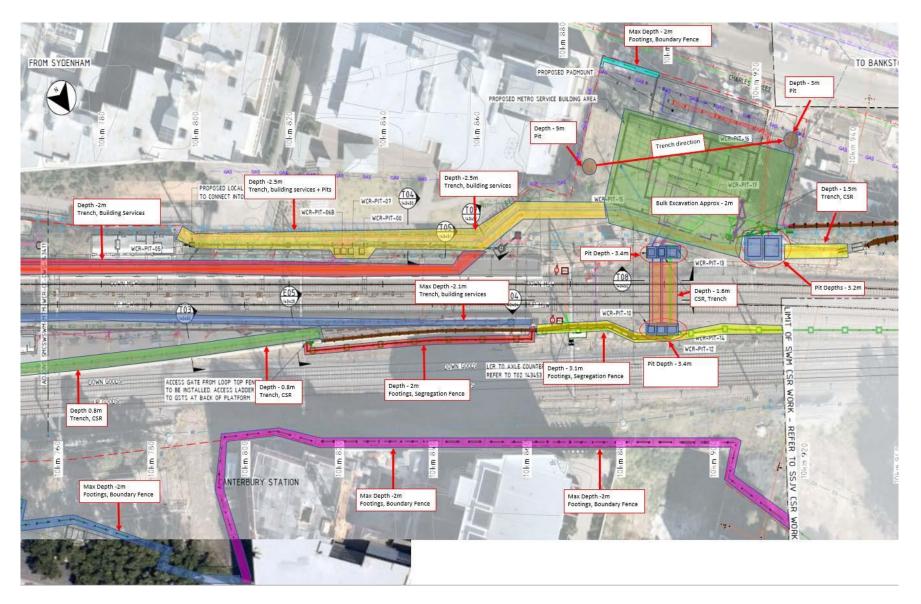
Plate 3.2 Plans showing the extent of remaining works at Canterbury Station that involve excavation, including the MSB site to the western extent of the project boundary (Source: HSEJV 2021).

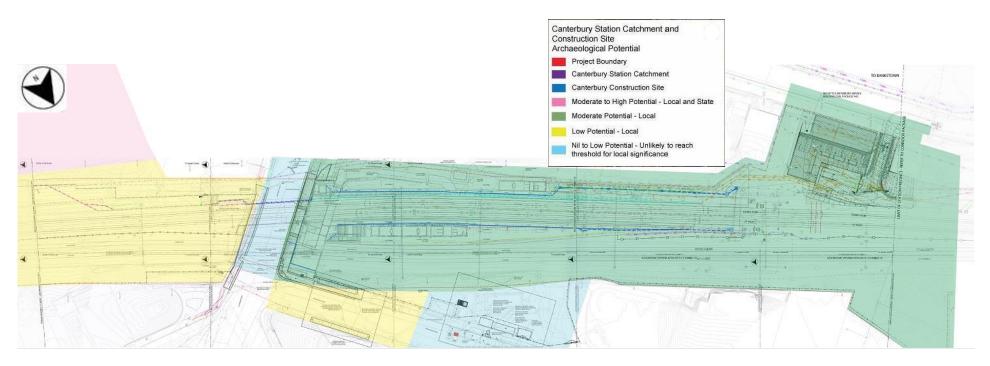
Plate 3.3 Impacts shown against archaeological potential. Note that north is down. Source: Plans - Metron T2M Civil Engineering Package No.143); archaeological potential shading – Artefact Heritage 2018, Fig 4-4, p.80.

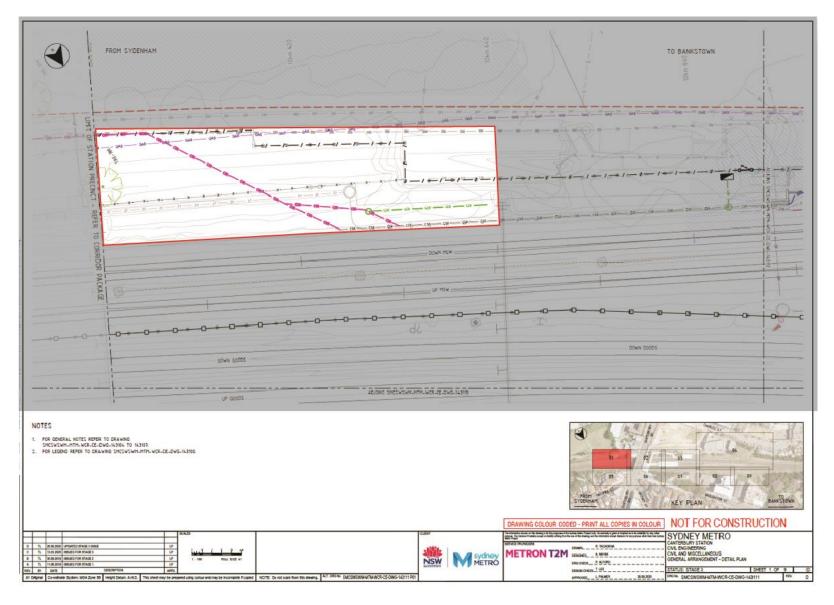
Plate 3.4 An excerpt from the civil drawing package showing the location of the GST fencing (red rectangle; highlight). Note that north is down (Source: Metron T2M Civil Engineering Package No.143).

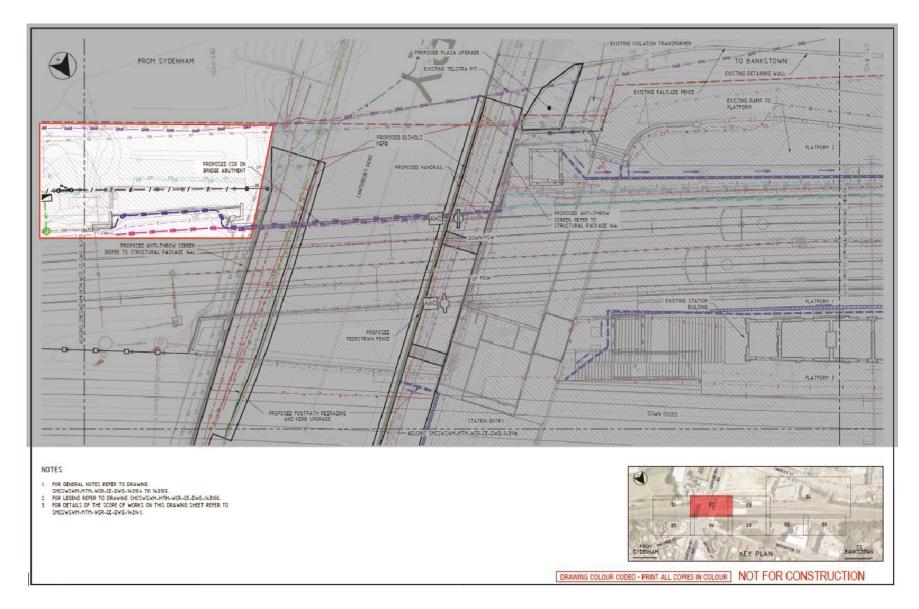
Plate 3.5 Location of proposed services in the location of c1840s building (red rectangle; highlight) adjacent to the CSR fencing. Note that north is down (Source: Metron T2M Civil Engineering Package No.143).

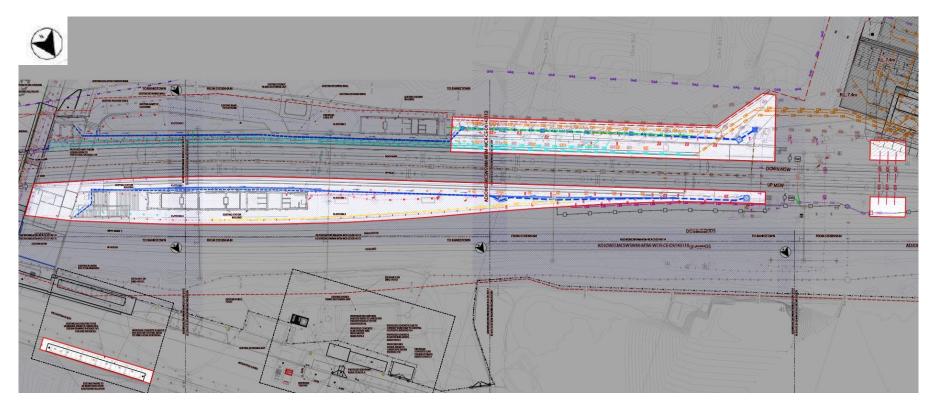
Plate 3.6 Areas for archaeological monitoring. (Source: Metron T2M Civil Engineering Package No.143).

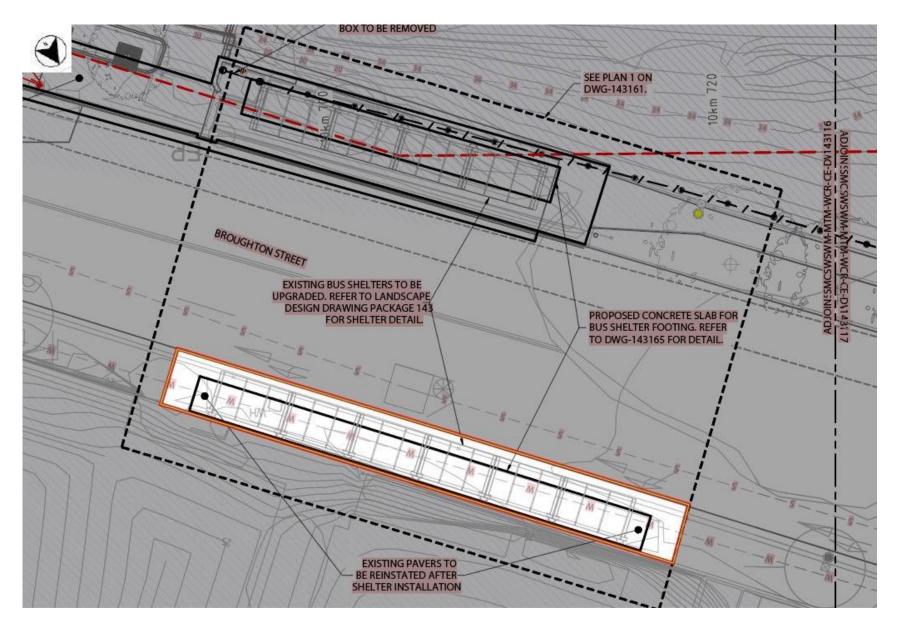
Plate 3.7 Works to the existing bus shelter will be occurring in the highlighted area. (Source: Metron T2M Civil Engineering Package No.143).

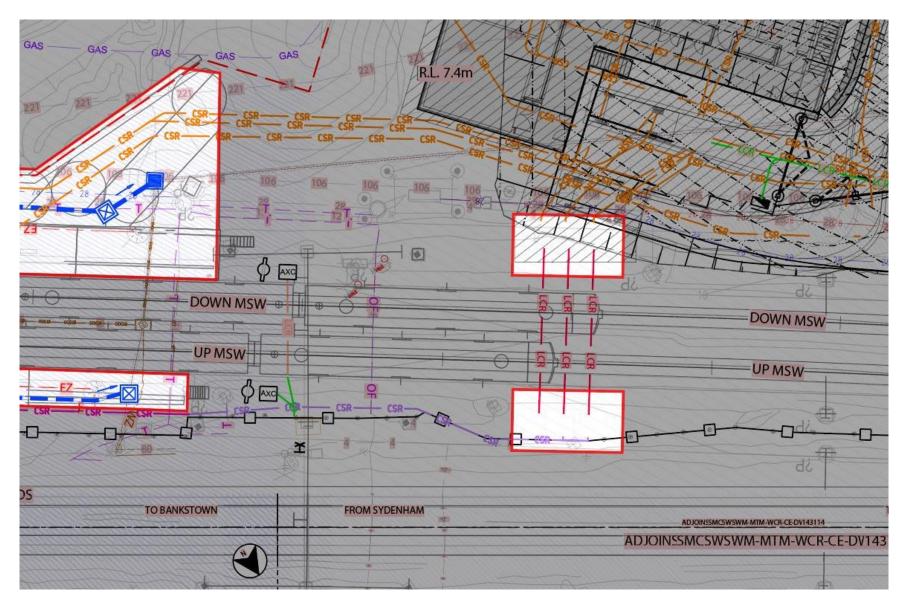
Plate 3.8 The approximate location of cut and cover pit excavation (two rectangles) for the LCR services. (Source: Metron T2M Civil Engineering Package No.143).

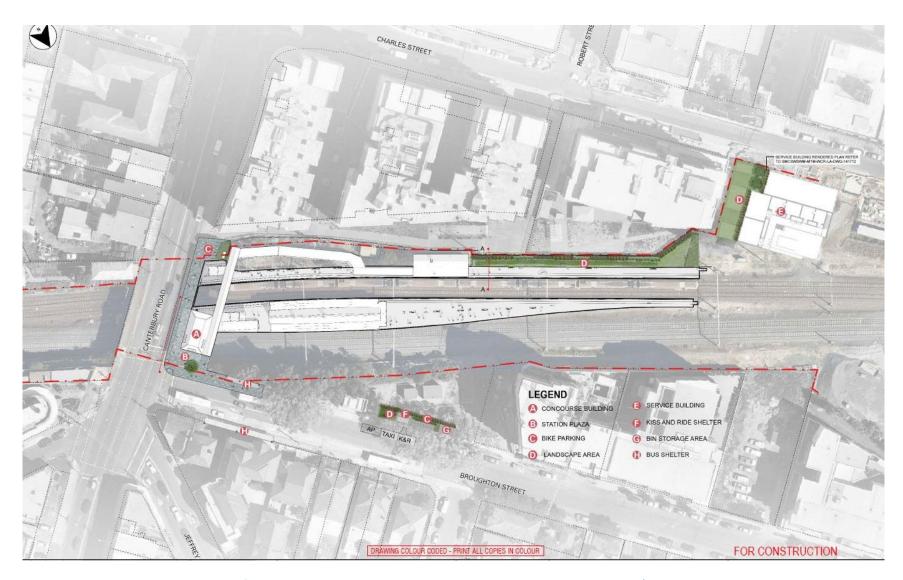
Plate 3.9 The landscaping plan for Canterbury Station – vegetation to be planted in the green areas (Source: Metron T2M Civil Engineering Package No.143).
