Lakemba Station Catchment Construction Works

Archaeological Method Statement 2

Prepared for HSEJV
May 2021

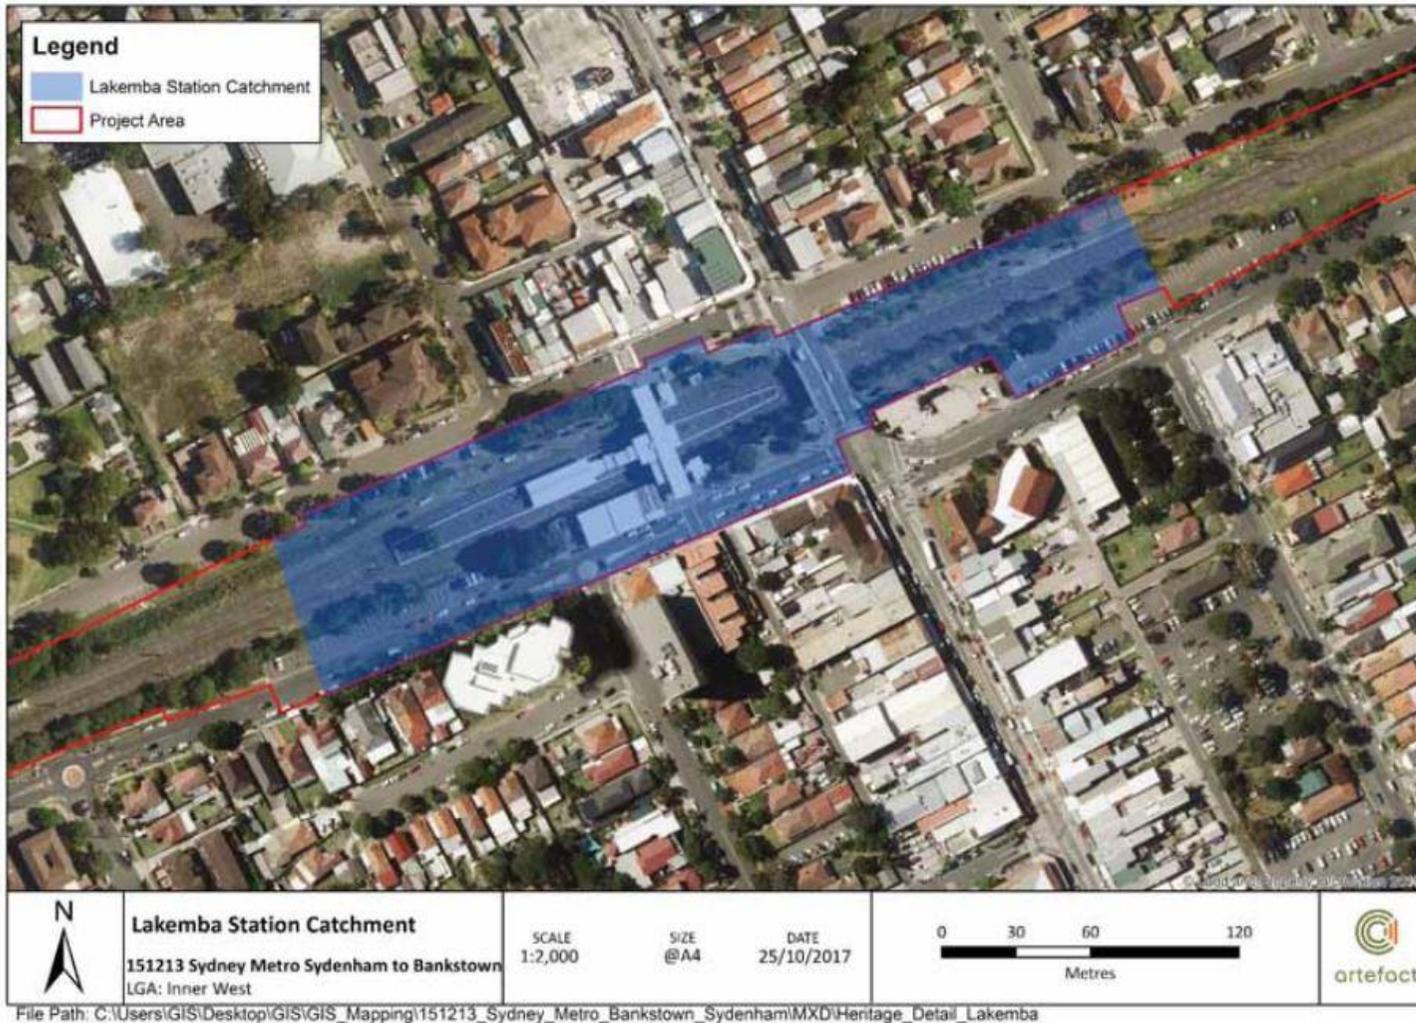
Plate 1.1 The Lakemba Catchment project area. Source: Artefact Heritage 2018 Figure 6-1, p.107

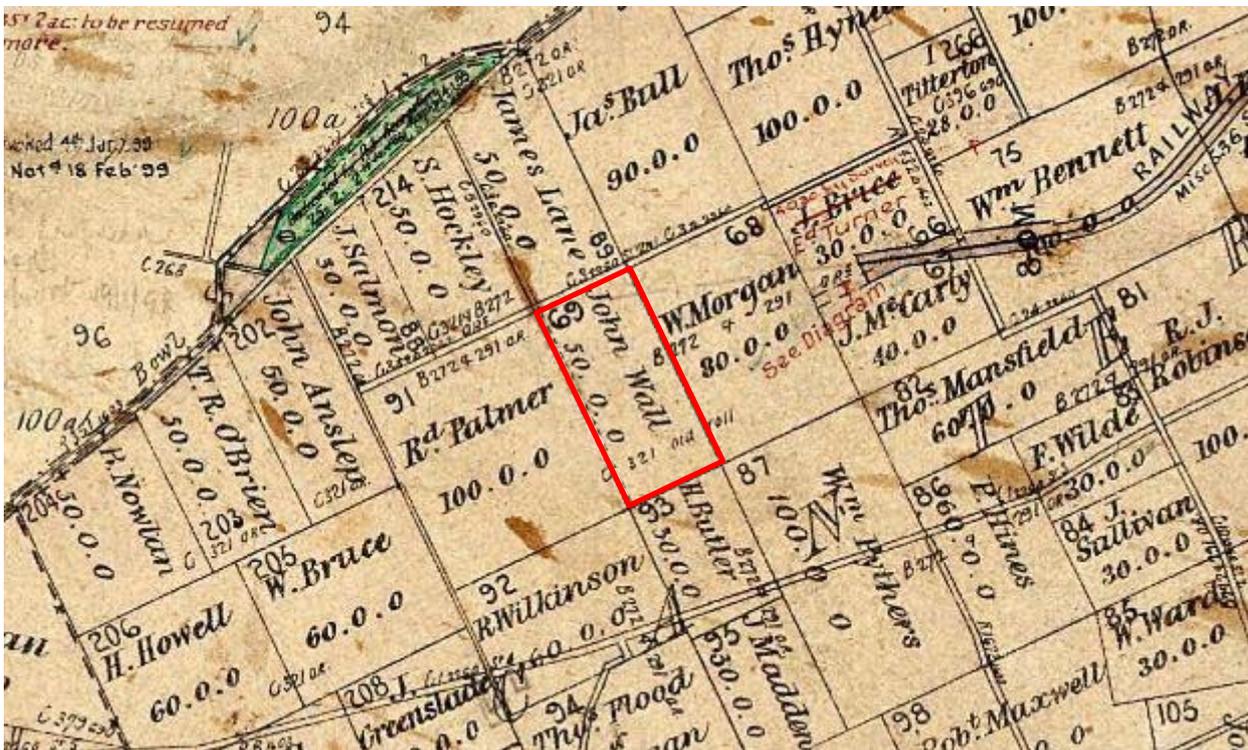
Plate 1.3 Parish of St George plan, c1889, showing John Wall’s land grant of 50 acres. Source: HLRV; Canterbury Bankstown Image Collection.

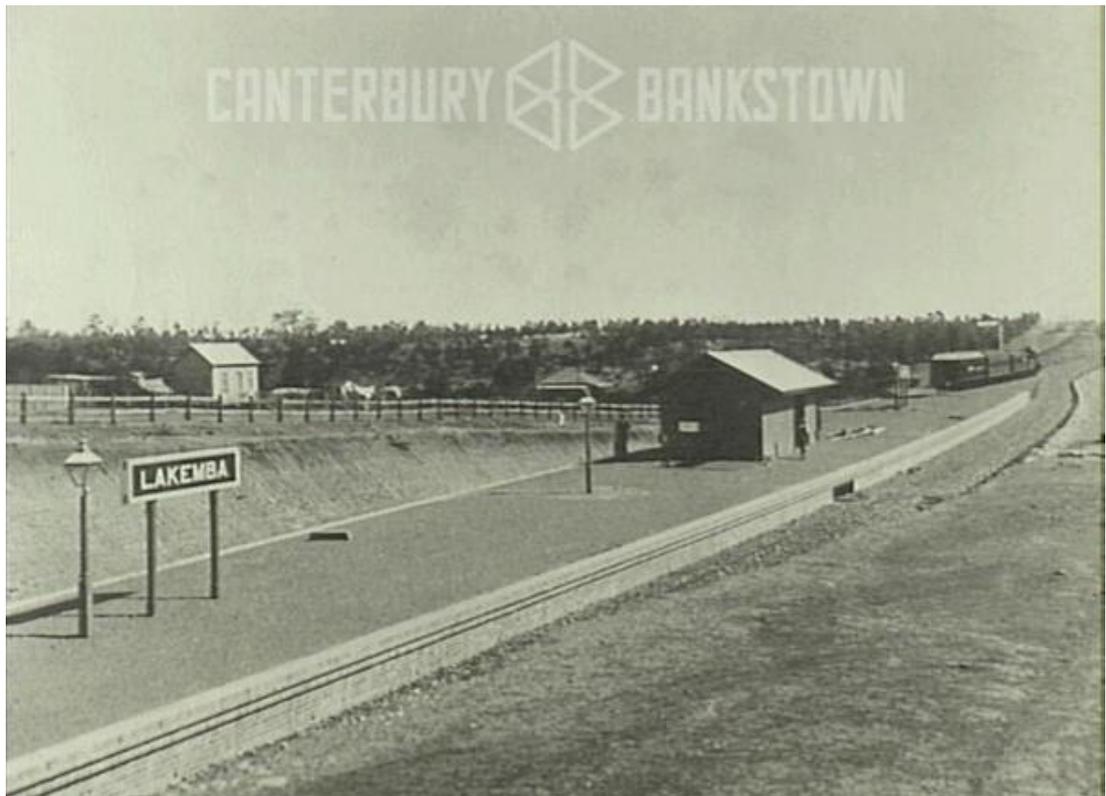
Plate 1.7 Lakemba Railway Station c1909, view south-west with The Boulevard in the background. Note the platform size and coping. Source: Canterbury Bankstown Image Collection.

Lakemba Station was opened on the 14 April 1909. The original station at Lakemba had an island platform with entrance steps from the Haldon Street overbridge. A small timber building with a ticket and parcels office was located at the eastern end of the station.

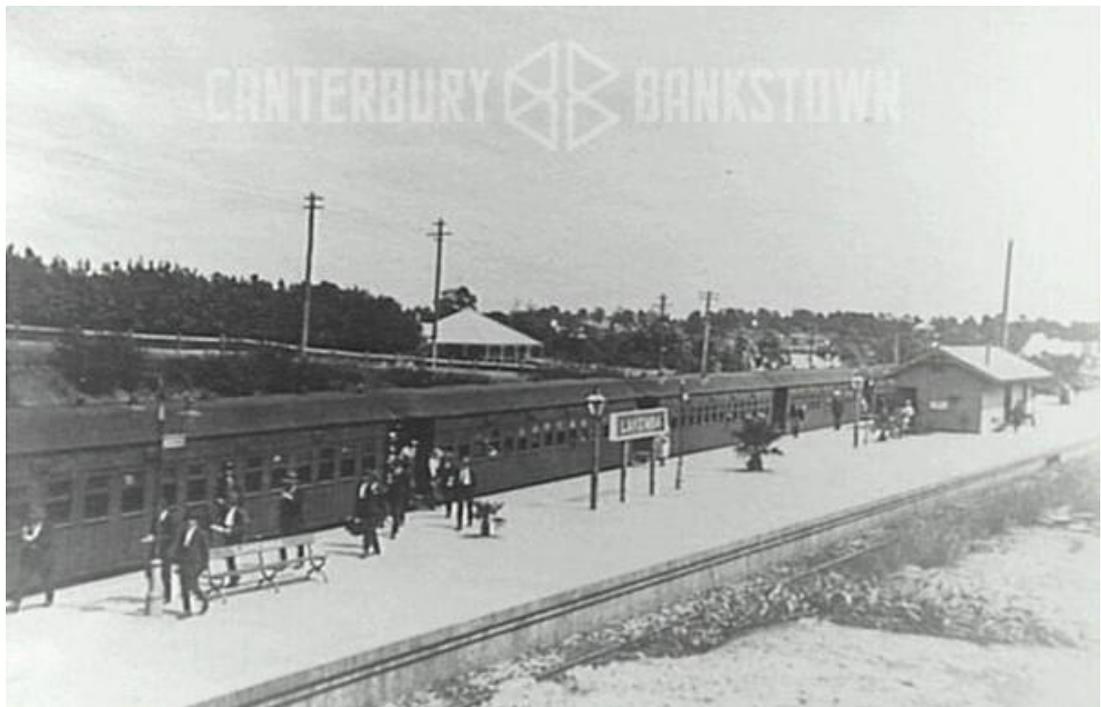
Plate 1.8 Lakemba Railway Station platform, c 1910, view south-west. Note the gas lamps on the platform. Source: Canterbury Bankstown Image Collection.

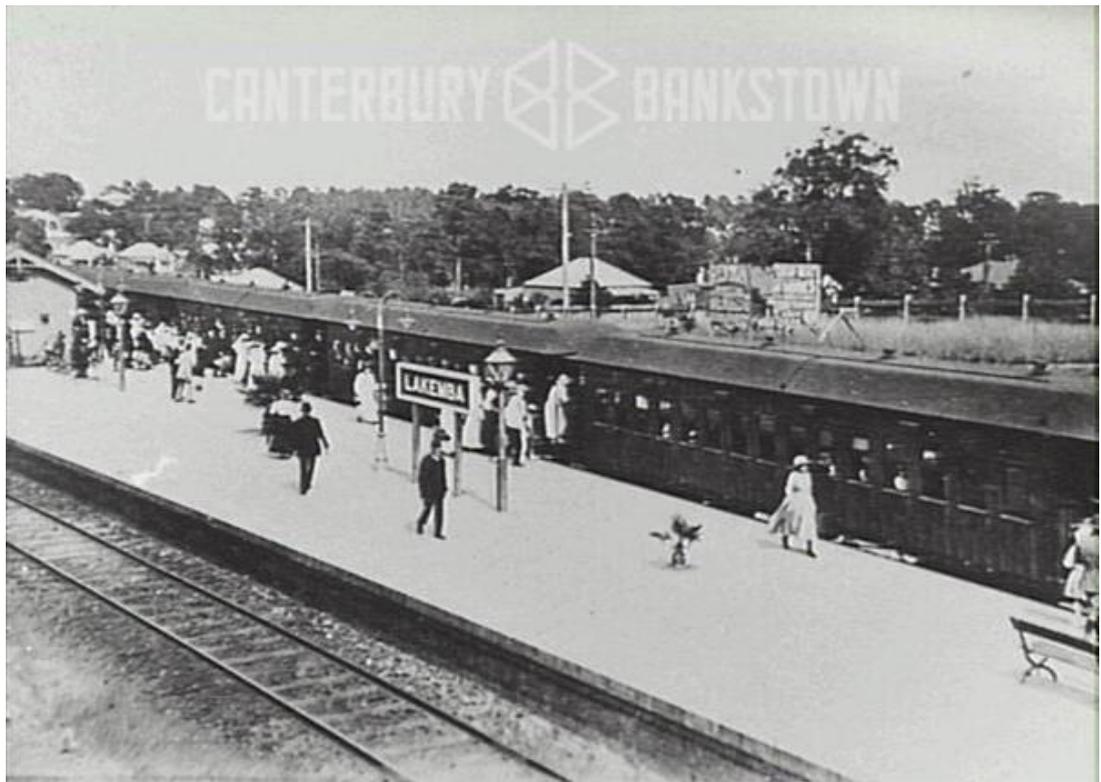
Plate 1.9 Lakemba Railway Station platform, c 1910, view north-west to Railway Parade. Source: Canterbury Bankstown Image Collection.

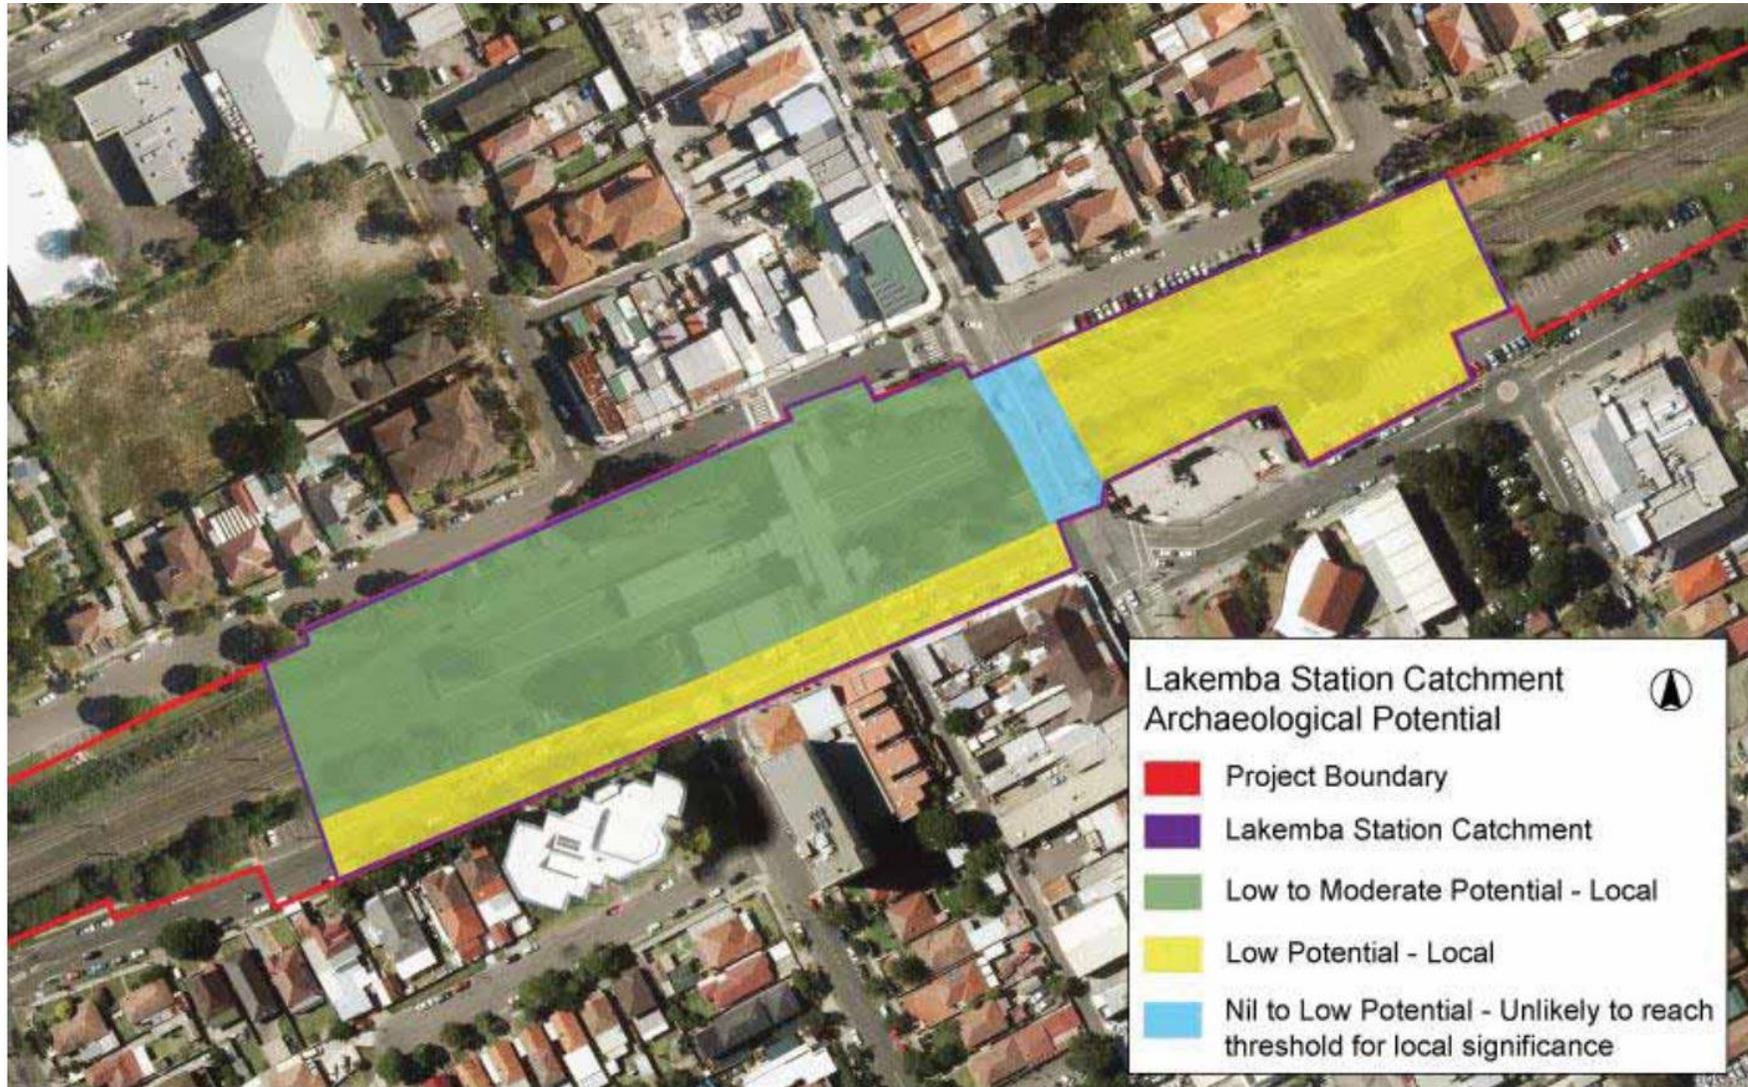
Plate 1.10 Archaeological potential of Lakemba Station. Construction activities will be occurring throughout the shaded areas. Source: Artefact Heritage Figure 6-18, p.121.

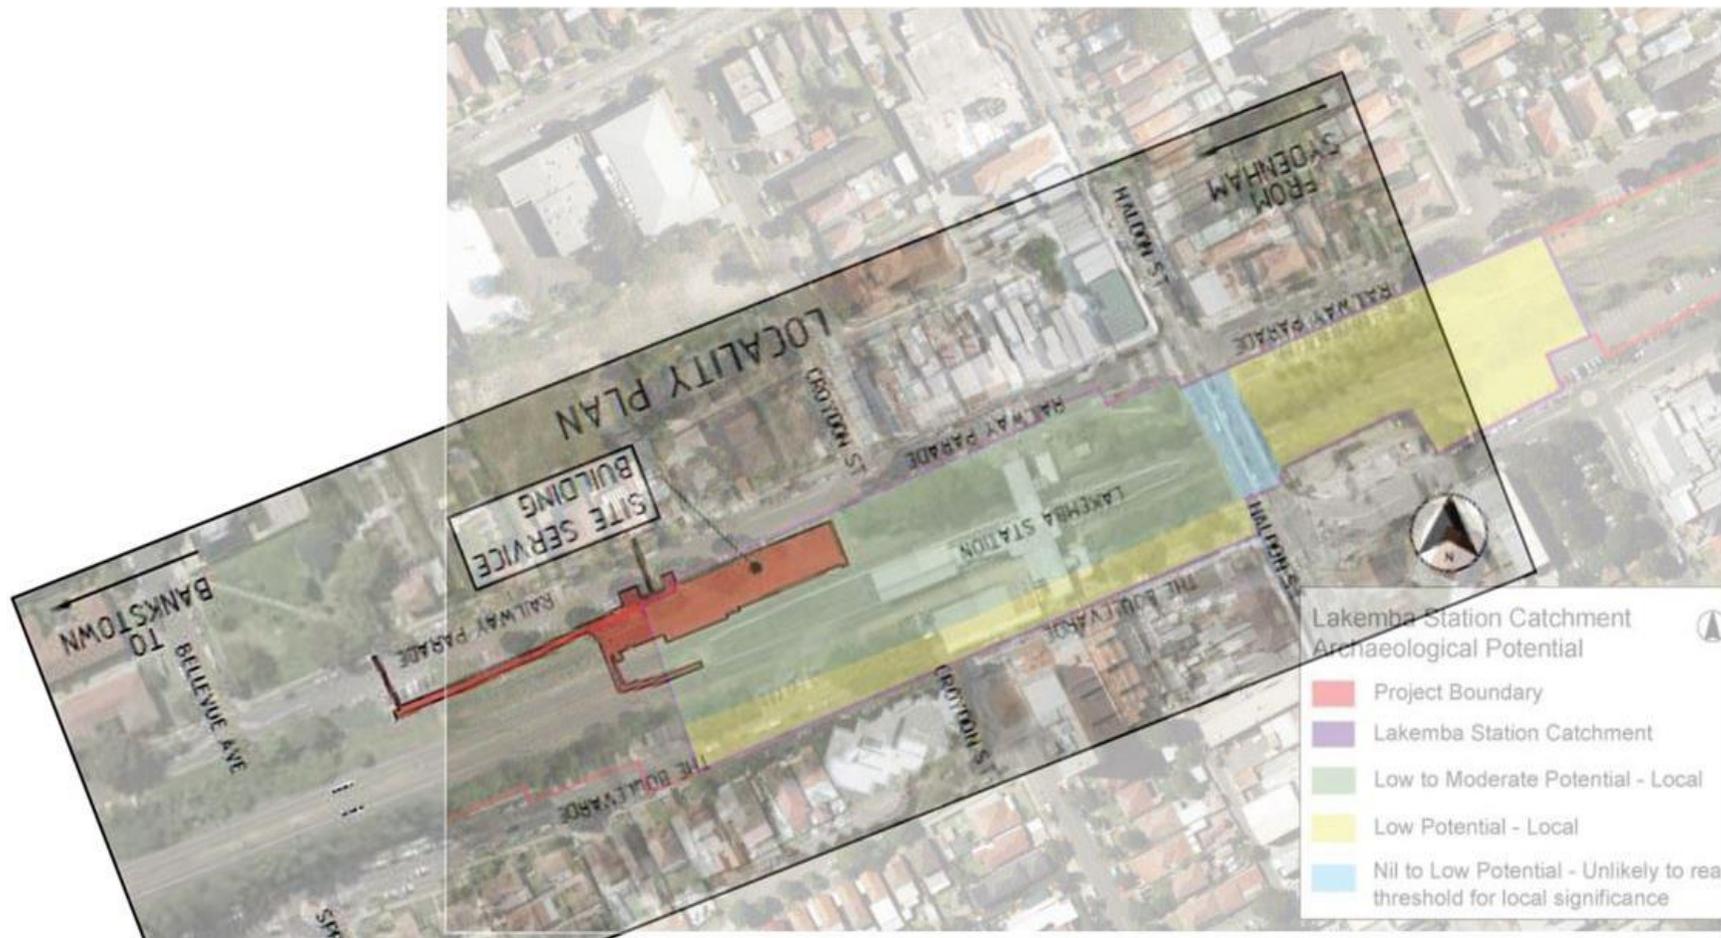
Plate 3.1 The location of the proposed Metro Services Building overlaid on the archaeological potential map. Source: Archaeological potential - Artefact Heritage Figure 6-18, p.121; Construction plan – Metron T2M.

Project activities will be occurring on site during possession weekends, shutdowns and out of possession periods, where the rail corridor is not affected. The impacts described are not in the planned order for the possession periods as the archaeological program must respond if the construction program changes. The nature and extent of these works are shown in , Plate 3.1 and Plate 3.2.

- Metro Services Building (MSB) (Plate 3.1)
 - Potholing/investigations to locate services and for contamination testing;
 - bulk cut and fill earthworks to a depth of between 2.5 m and 3 m (Plate 3.2);
 - detail excavation for the pad footing;
 - piling for the radio mast and pile cap;
 - soil nail remediation to existing rail embankments; and
 - driveway and crossover construction.
- potholing to locate services on station platforms;
- piling on station platforms and in the rail corridor;
- cut and fill to construct drainage inside the rail corridor and cess;
- platform re-levelling to a depth of 500 mm;
- cut and cover to install services;
- post installation for fencing and Galvanised Steel Troughing (GST) support and for trackside infrastructure;
- modifications to the car park;
- landscaping;

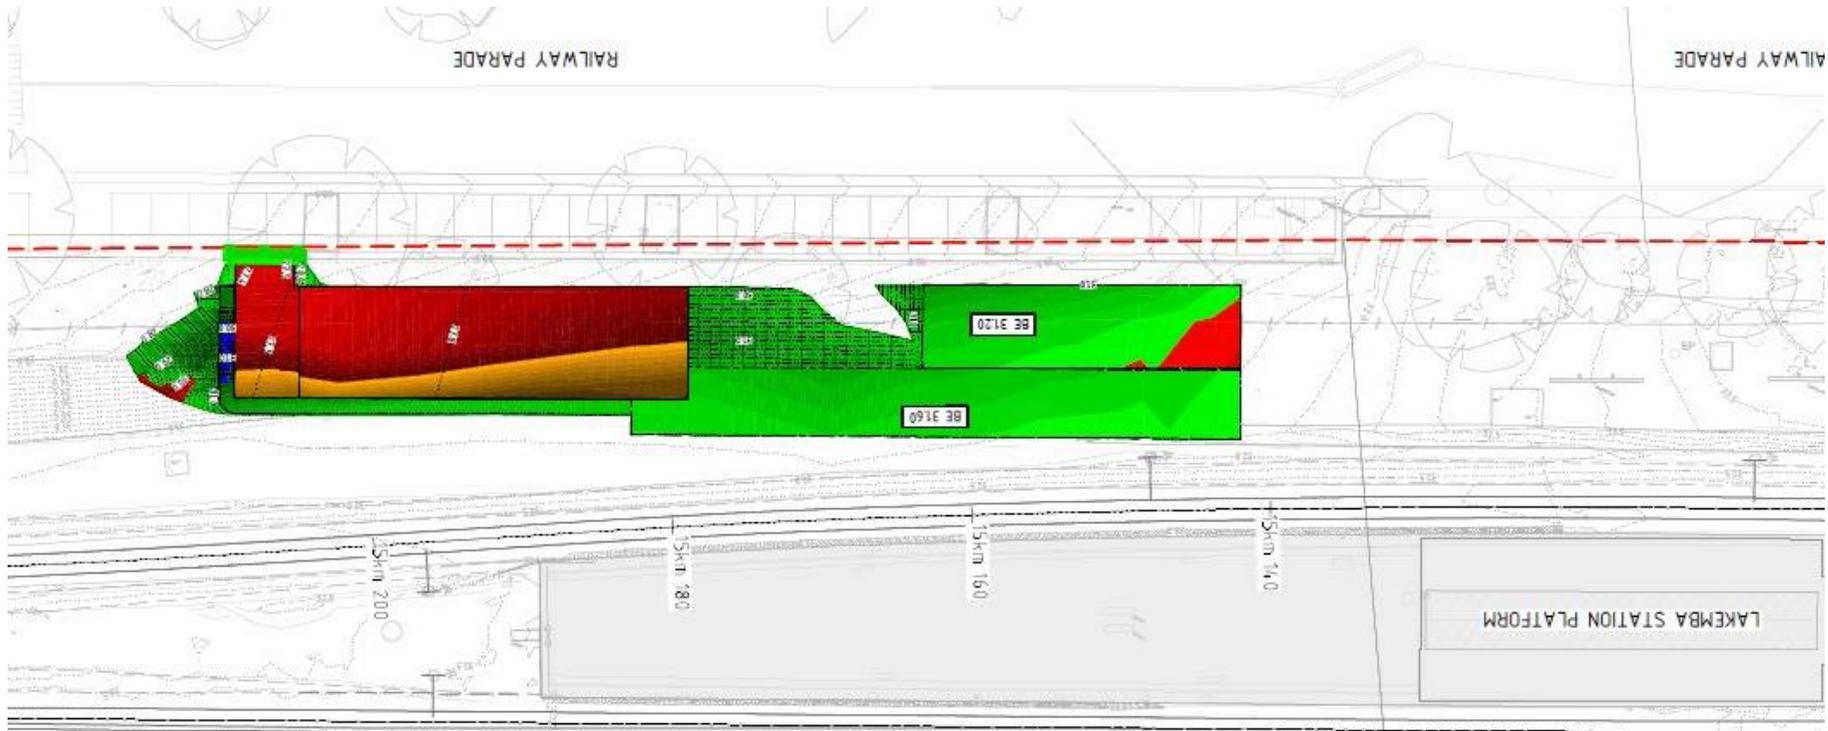
Plate 3.2 Bulk excavation in the location of the proposed MSB. North is down. Source: Metron T2M (red is deep excavation for the padmount area green is fill over the MSB area; refer to Appendix B for the full plan with key). North is up.
