*Southwest Metro Station Upgrade Works Package 4:
Marrickville, Canterbury & Lakemba Stations*

HSEJV Construction Monitoring Report: Sept 2021 – Feb 2022

Document Number: SMCSWSW4-HSE-WEC-EM-REP-006290

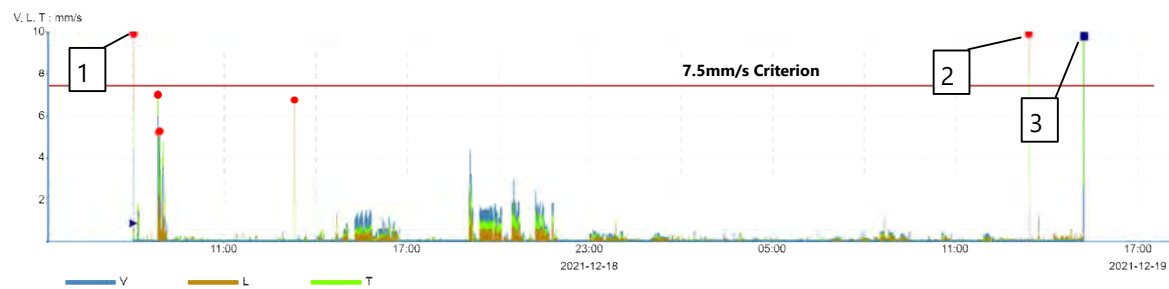
Figure 3-1: Unattended vibration monitoring at Canterbury Station results (refer to Appendix A.1)

It can be seen in Figure 3-1 and Figure 3-2 that the vibration levels produced from the vibration intensive works in the vicinity of the affected structures is below 7.5 mm/s. Note that there were events that resulted in an instantaneous vibration level of above 7.5 mm/s, however these were not caused by the nearby construction activities, as justified in Table 3-1.

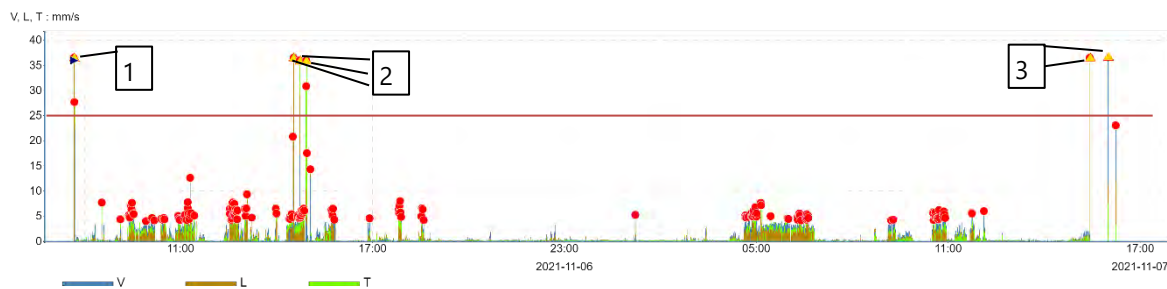
Figure 4-1: Unattended vibration monitoring results (refer to Appendix A.7)

It can be seen in Figure 4-1 that the vibration levels produced from the nearby rockhammering works are below 25 mm/s. Note that there were events that results in an instantaneous vibration level of above 25 mm/s which are justified in Table 4-2.
