Southwest Metro Station Upgrade Works Package 4: Marrickville, Canterbury & Lakemba Stations

HSEJV Construction Monitoring Report: March – August 2022

Document Number: SMCSWSW4-HSE-WEC-EM-REP-007659 Revision Date: 31/10/2022 Revision: B

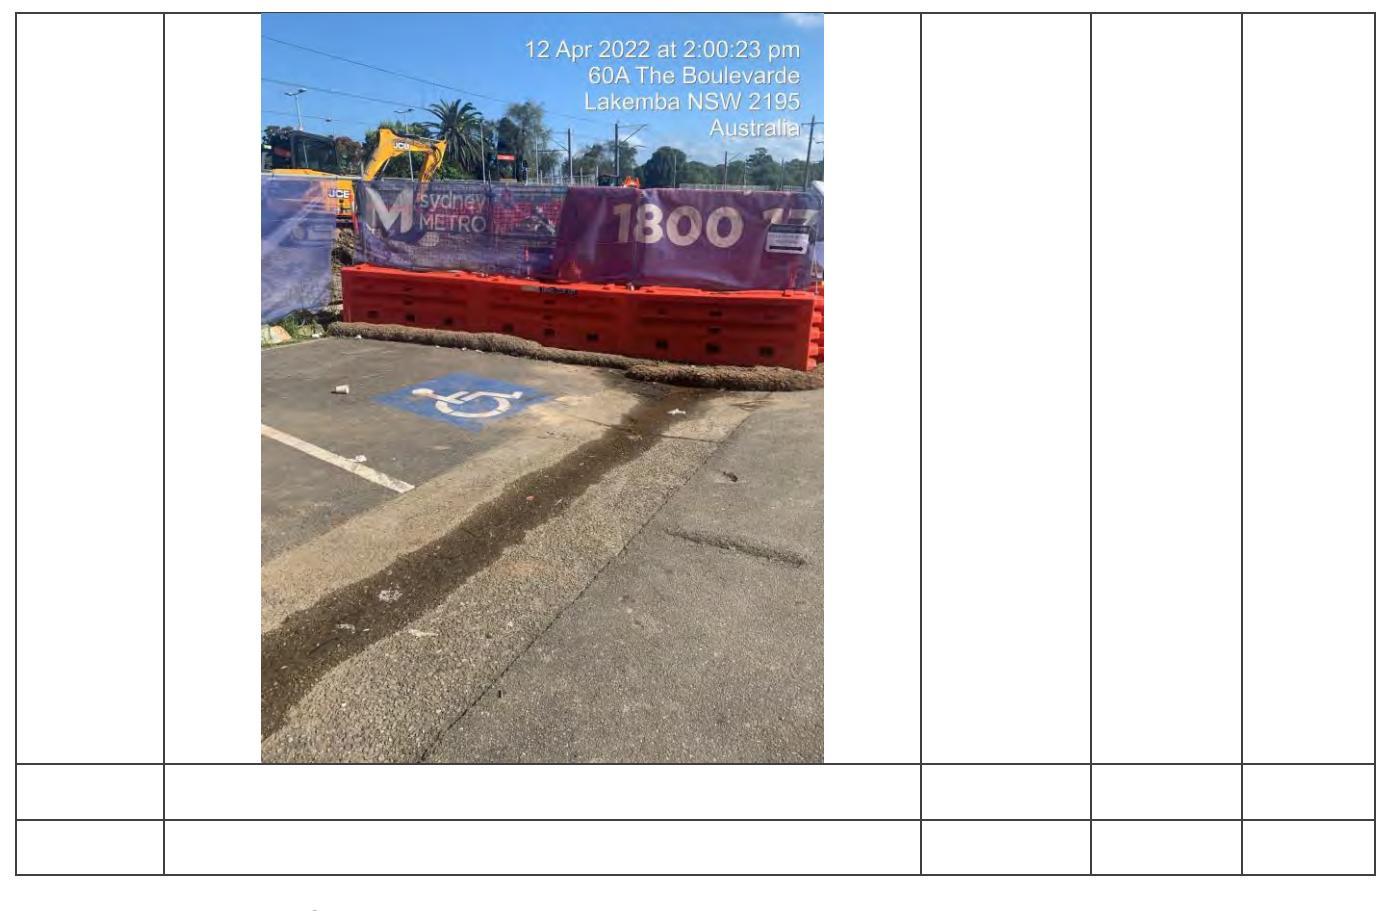
32.09 Railway Parade Accessible car parks	Issue: It was noted that signage for the car park relocation did not indicate a period for the relocation. Action: HSEJV agreed to include a timeframe on the signage. Signage for the possession of the car parks has been removed (See photo), as the timeframe for these works has been extended to the beginning of May. New signage will be installed closer to the date of possession with the period of relocation on the signs		12.4.22
	12 Apr 2022 at 2:00:14 pm 46-52 railway Pde NSW 2195 Australia 88 LLL 00 tornation line 90 peulogui Aguntu 66

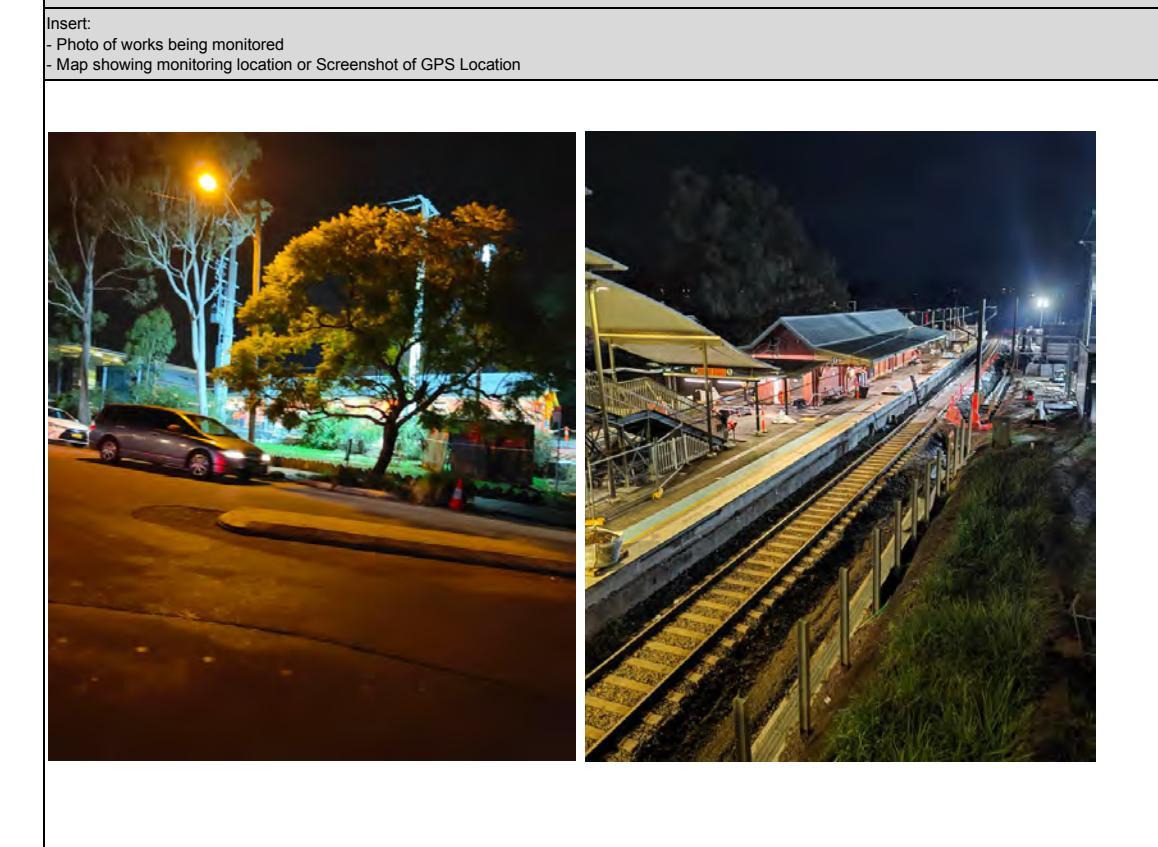
DIAGRAMS AND PHOTOS

21:23	21:38	E	52	80	
		MEASUREMENT RESULTS (15 MI	N PERIOD) from activity		
L _{aeq}	L _{max}	L _{min}	L _{A10}	L _{A90}	
54.1	69.6	49.4	-	-	
MONITORING OBSERVATIONS:					
XL2 file number:					
Time	Source noise	Extraneous noise	LAF	Other comments	
XX:01	hand tool - hammering		56.9		
XX:02	people talks		63		
XX:03	hand tool - hammering		56.3		
XX:04	hand tool - hammering		56.9		
XX:05	hand tool - hammering		53.9		
XX:06	car passed		56.9		
XX:07	car passed		56.5		
XX:08	car passed		55.8		
XX:09	car passed		61.6		
XX:10	people talks		54.3		
XX:11	car passed		66.5		
XX:12	car passed		63.2		
XX:13					
XX:14					
XX:15					
Further actions required to reduce noise?					
Additional comments	1. Works audible (powered i 2. Measurement influenced	handools used to install rios on the pl by road traffic.	atform)

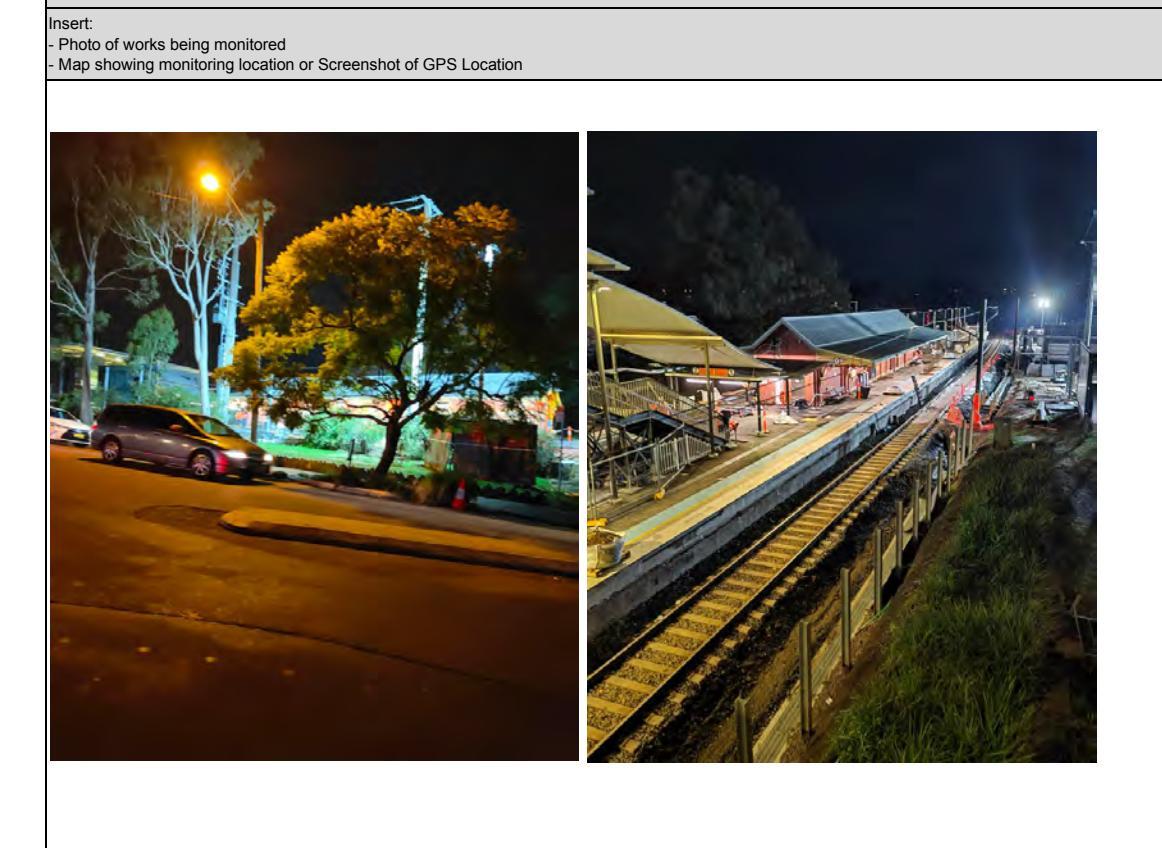
DIAGRAMS AND PHOTOS

23:42	23:57	Ν	46	80			
		MEASUREMENT RESULTS (15 MI	N PERIOD) from activity				
L _{aeq}	L _{max}	L _{min}	L _{A10}	L _{A90}			
52.7	68.1	48.6	-	-			
MONITORING OBSERVATIONS:							
XL2 file number:							
Time	Source noise	Extraneous noise	LAF	Other comments			
XX:01	car passed		59.3				
XX:02							
XX:03	car passed		52.6				
XX:04	car passed		57.6				
XX:05	car passed		62.8				
XX:06	car passed		50.4				
XX:07	grinder used -hand tool		52.7				
XX:08	grinder used -hand tool		52.1				
XX:09	car passed		55.9				
XX:10	car passed		68				
XX:11	car passed		57.7				
XX:12	car passed		59.9				
XX:13							
XX:14							
XX:15							
Further actions required to reduce noise?							
Additional comments	1. Works audible (powered l 2. Measurement influenced	handools used to install rios on the pl by road traffic.	atform)

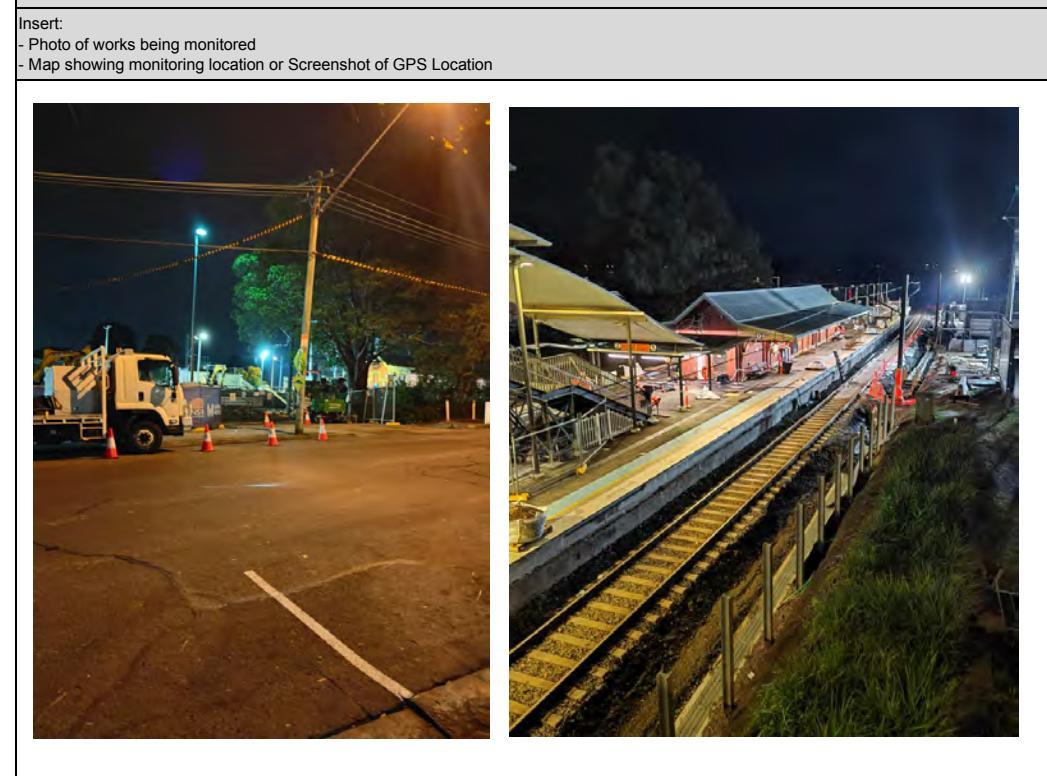
DIAGRAMS AND PHOTOS

23:20	23:35	Ν	46	70			
		MEASUREMENT RESULTS (15 MI	N PERIOD) from activity				
L _{aeq}	L _{max}	L _{min}	L _{A10}	L _{A90}			
52.7	68.1	48.6	-	-			
MONITORING OBSERVATIONS:							
XL2 file number:							
Time	Source noise	Extraneous noise	LAF	Other comments			
XX:01	bus passed		74.3				
XX:02	bus passed		67.4				
XX:03	car passed		70.1				
XX:04	car passed		70.8				
XX:05	hand tool - hammering		74.6				
XX:06	bus passed		51.2				
XX:07			75.5				
XX:08	bus passed		74.5				
XX:09	car passed		70.3				
XX:10	hand tool - hammering		51.2				
XX:11	bus passed		76.9				
XX:12	hand tool - hammering		50.2				
XX:13	bus passed		75.5				
XX:14	hand tool - hammering		49				
XX:15	bus passed		75.7				
Further actions required to reduce noise?							
Additional comments	1. Works audible (powered I 2. Measurement influenced	handools used to install rios on the pl by bus replacement traffic.	atform)
